Non-Frame Method employed for the slope failure prevention project at the Second Toba district, Toba city, Mie Prefecture

Shima Construction Office, Nansei Bureau,
Mie Prefectural Government

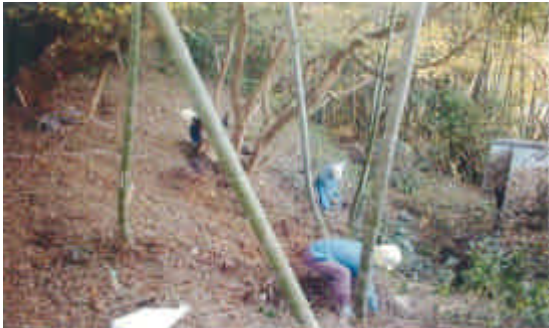
The slope is as high as 40 meters and is located eastern part of the steep range of hills. The slope is as steep as 30 degrees or more up to 50 degrees and covered well with thick natural vegetation, but the slope surface has been heavily weathered so that the area was prone to rock fall and slope failure.

The situation of steep slope with broad leaf tree and bamboo

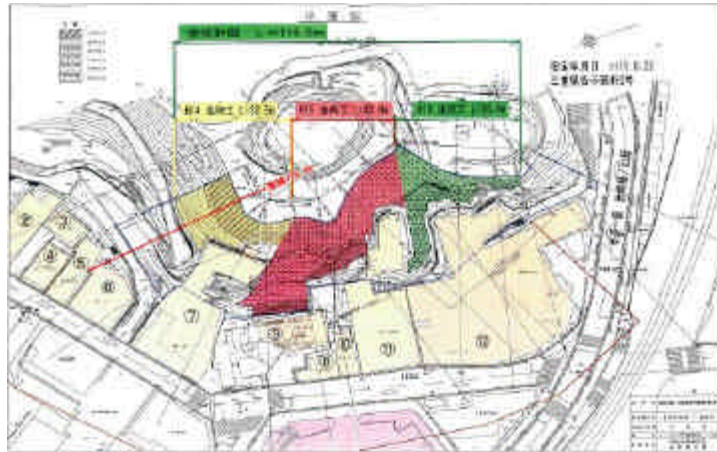
Design plane figure

- (1) unstable talus deposit on the base rock consisted of green schist, black schist and sand schist,
- (2) a fractured zone was identified on the south end of the slopes. Slope failure might therefore take place along the fractured zone,

- (3) a fractured zone which is running horizontally was identified on the north end of the slopes, but the dip of the fractured zone was identified to be opposite.

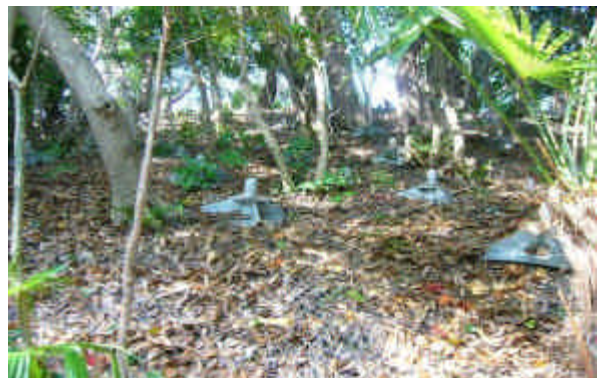
Completed
