# Report for Field Survey on Banjir Bandang

**TANGGAL 30 MARET 2009**

**DI KAB. TANAH DATAR PROF. SUMBAR**

**8 April,2009**

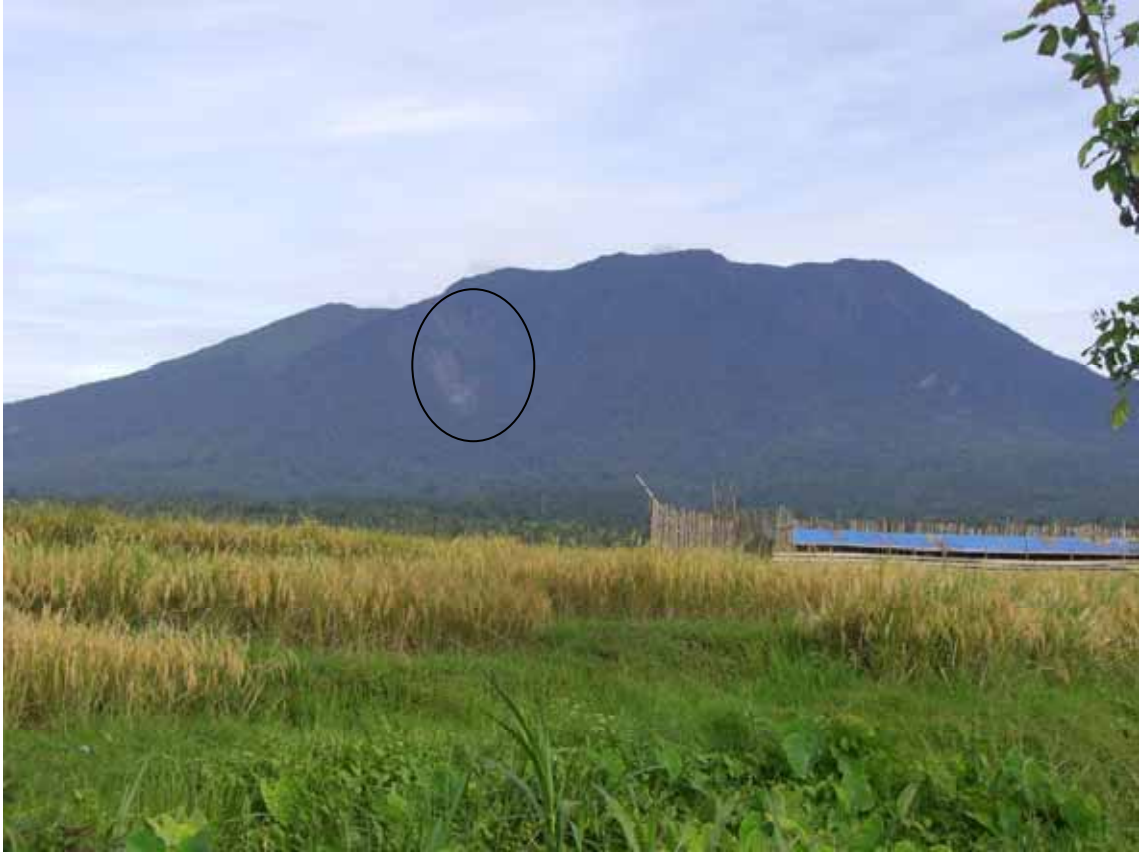
East side of Mt. Merapi

This collapse was formed in 6 March 2007 by earthquake. It is estimated that this collapse was formed in old days and product a lot of rock and sand.

And upper area is very steep slope. So if it rains, water runs down suddenly.

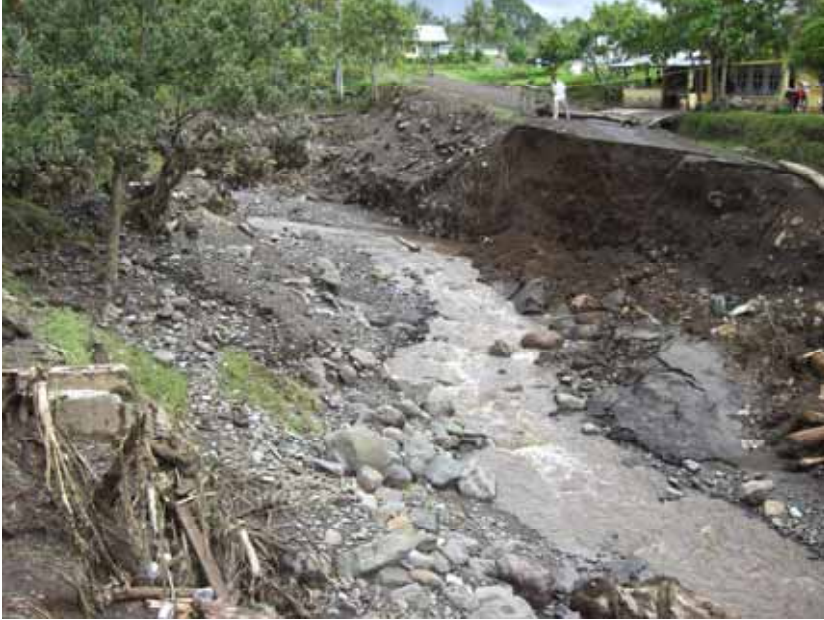
a) Site: Rao Rao

In this area, riverbank and river basement was eroded.

- 1) When the bank protection works are constructed, crossing facilities are recommended to protect the river basement.
- 2) In the middle of river where accumulated a lot of sediments, it is better to remove them and make sand pocket.
- 3) At serpentine rivers, if it is possible, they should be changed to flow smoothly.

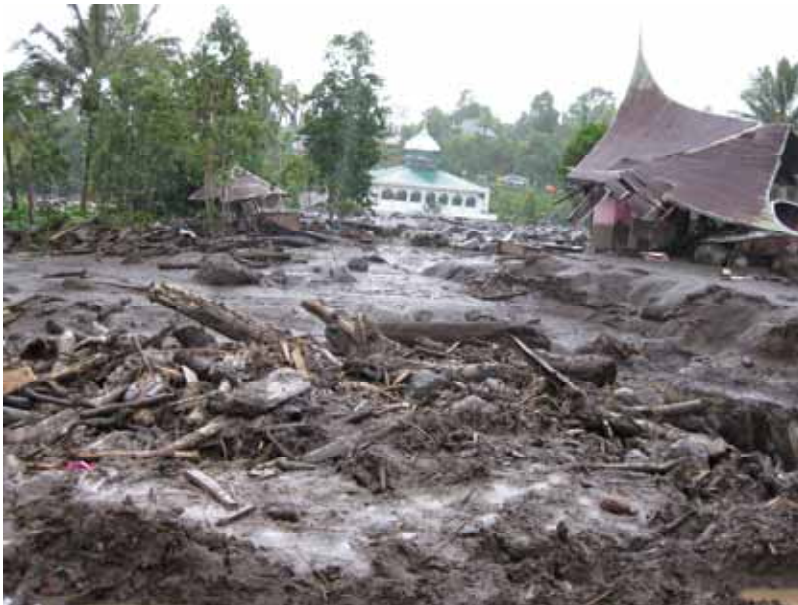
b) Site: Pasia Laweh

In this area 1 unit of mosque and 1 unit of market are damaged.

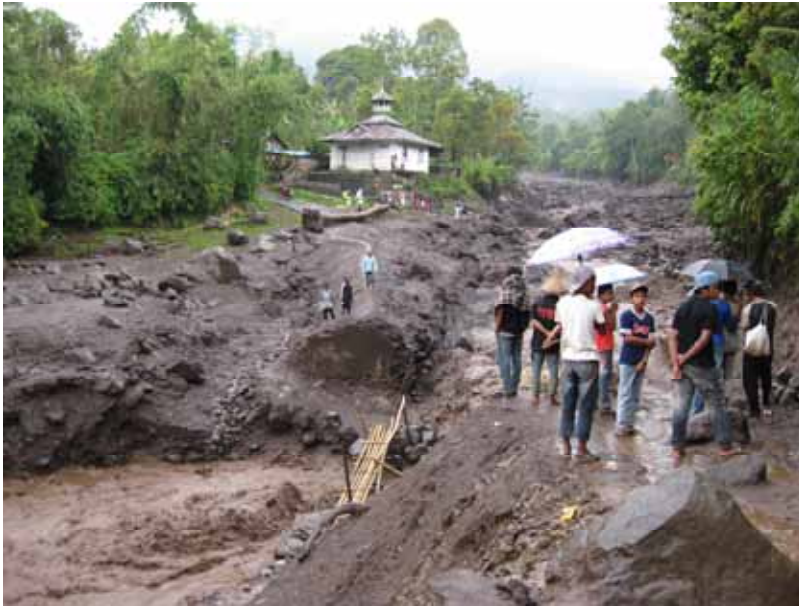
c) Site:

In this area, bridge was destroyed.

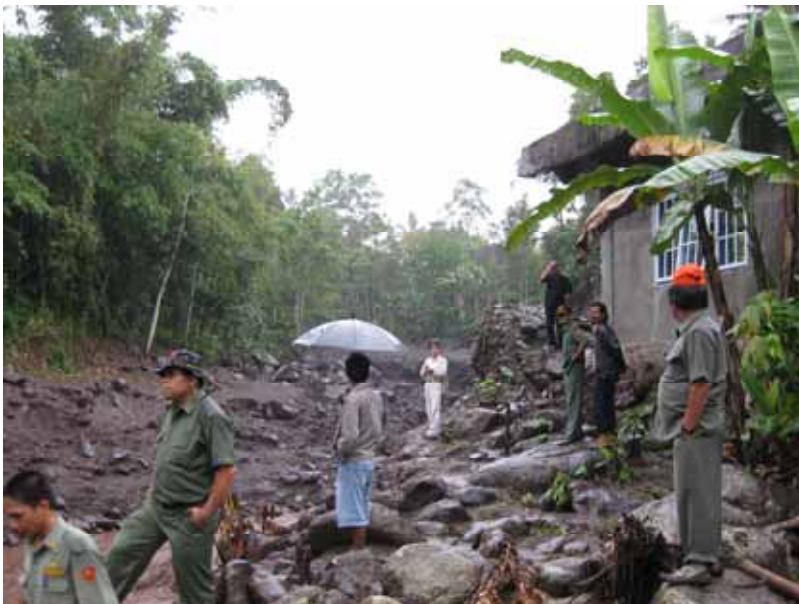
d) Site:

In this area, debris flow attacked the roof of house.

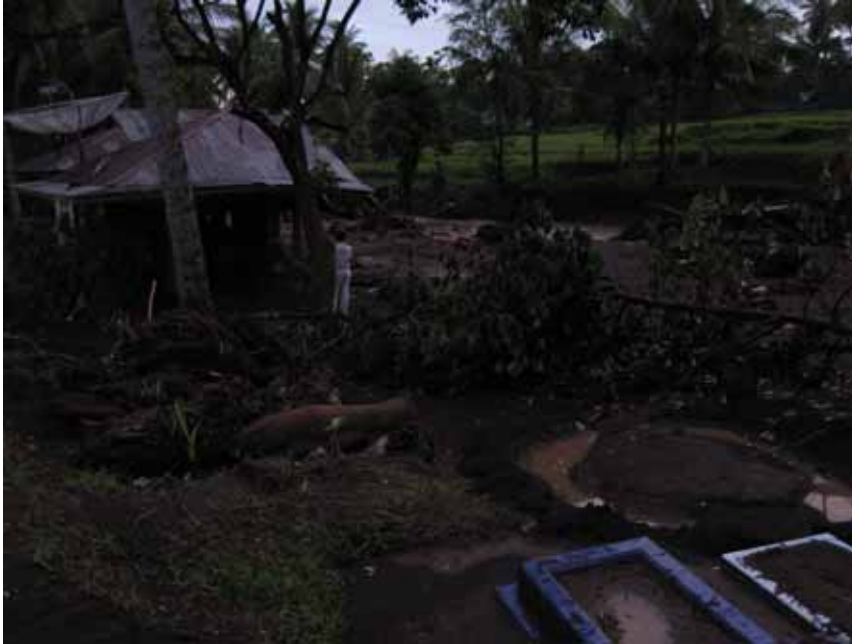
e) Site:

In this area, flood attacked the house and 5 people was missing.

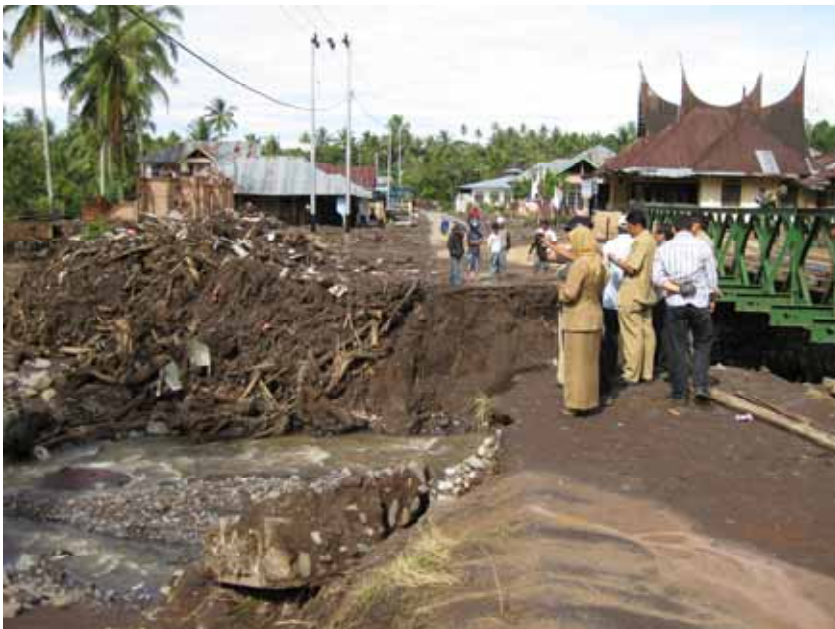
f) Site:

In this area, flash flood broke the bridge. The green bridge is under construction by army.

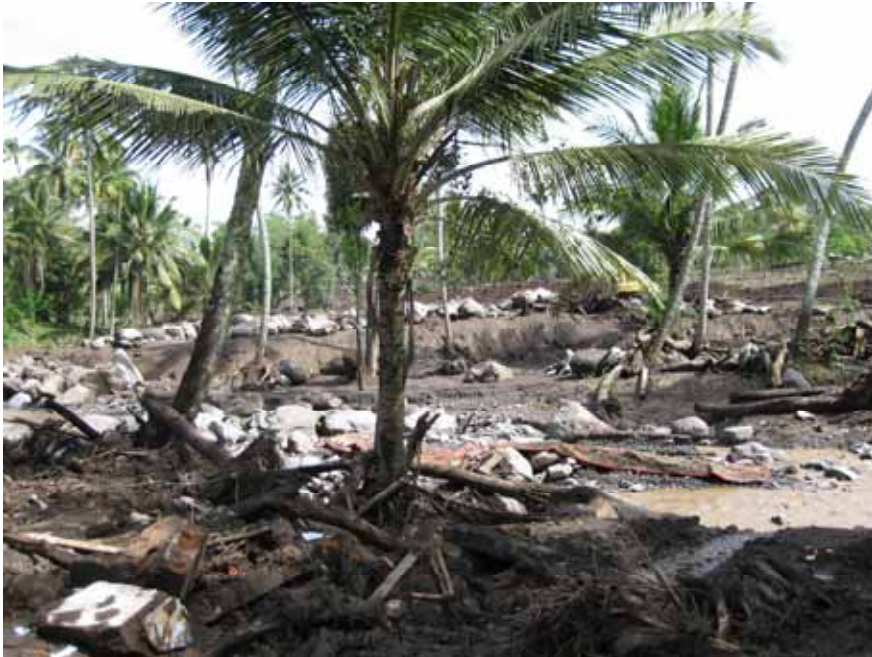
g) Site:

In this area, rocks sediment accumulated. And some houses were broken.

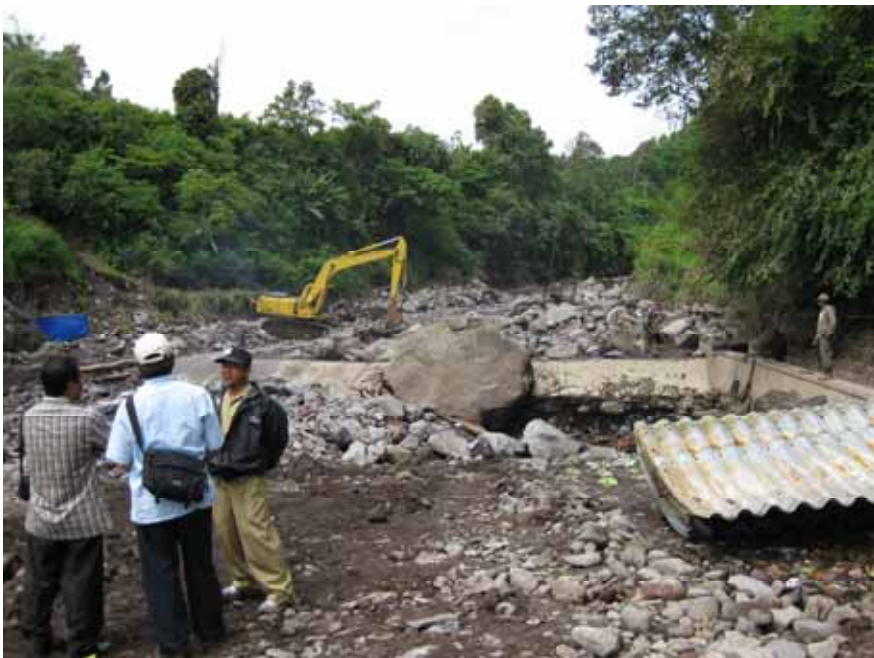
h) Site:

In this area, debris flow attacked the irrigation facility.
