# Sediment-related disasters during Typhoon No. 21 in September 2004 (Mie Prefecture)

Date: September 28, 2004  
 Place: Mie Prefecture  
 (Miyagawa Village and other areas)  
 Meteorological conditions:  
 Heavy rain due to Typhoon No. 21  
 Observatory  
 Miyagawa Gauging Station  
 Continuous rainfall  
 753 mm (9/28-29)  
 Maximum hourly rainfall  
 119 mm/hr (9/29 9:00-10:00)

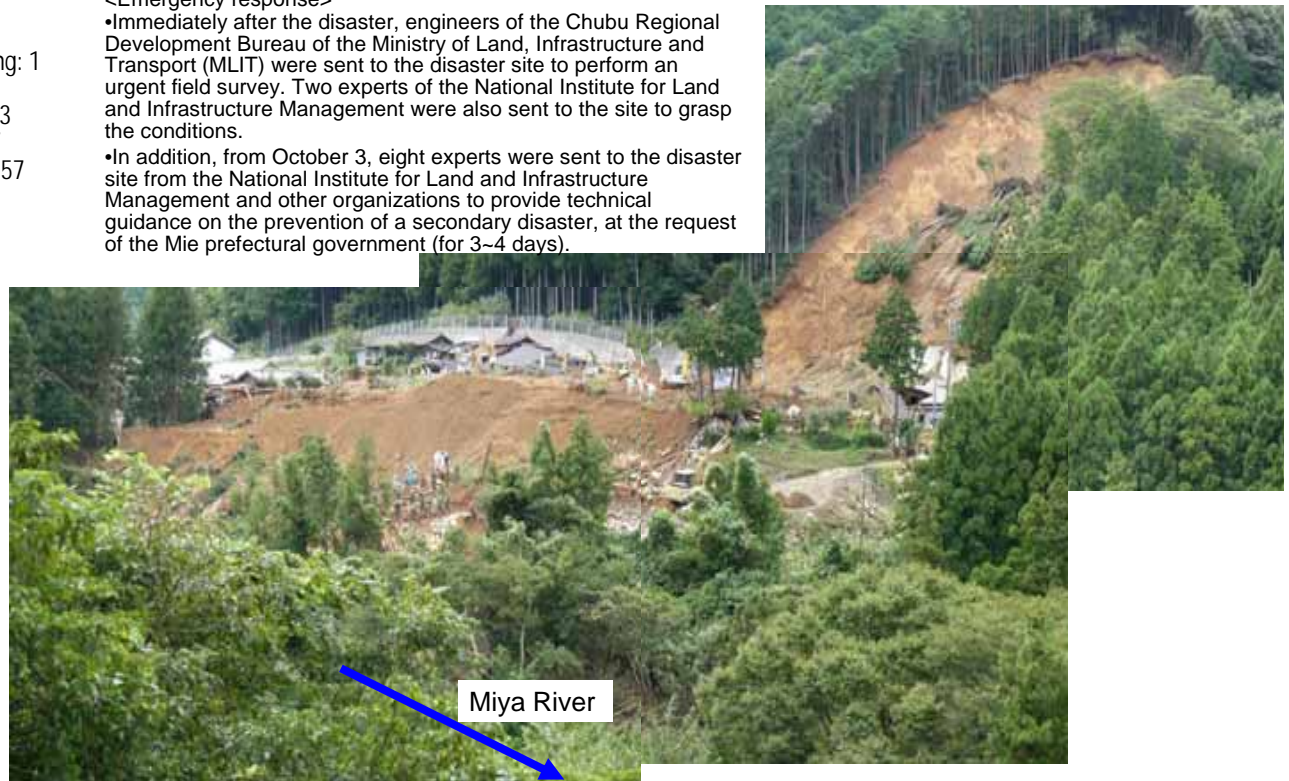
Two areas in Takiya, Miyagawa Village, Mie Prefecture  
 (killed: 4, missing: 1, total collapse: 3)
