St. Bernard Landslide, Southern Leyte, Field Report

Jesse C. Felizardo, Engineer, FCSEC, DPWH, Philippines
Yoshio Tokunaga, JICA Chief Adviser
Watatu Sakurai, JICA Sabo Expert

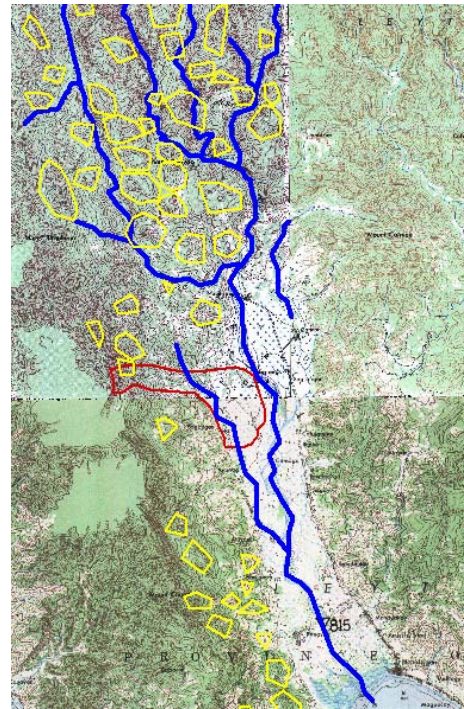
Figure 4, Topographical Map Overlaid with River Systems and Kerncol and Kernbut Around the Area

The major fault lines traverse the municipalities of Sogod, Libagon, St. Bernard and San Juan to Panaon Island. Fault lines run along the middle most stretch of the island of Leyte passing Guinsaguon at the lower tip. Please refer to Figure 4, the topographical map shows the river runs along the fault lines from north to south and the typical terrain has many kerncol and kernbut, enclosed with yellow polygons, which suggests that the area has been affected by existing active fault

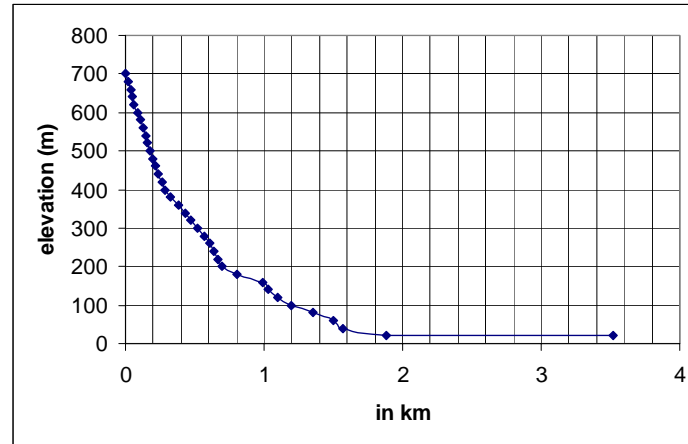
Figure 7 Slope Before the Landslide

The pre-landslide crown elevation was 700 m based on the topographic map with a maximum slope of 45°, mostly vegetated. It consists of sedimentary rocks such as upper Miocene, Pliocene as depicted in the geological map of Mines and Geoscience Bureau. Big boulders with tuff breccia can be found in the depositional area. Collapsed soil has high fluidity which flowed down up to 3 km, horizontal distance, see .Figures 7 and 10.

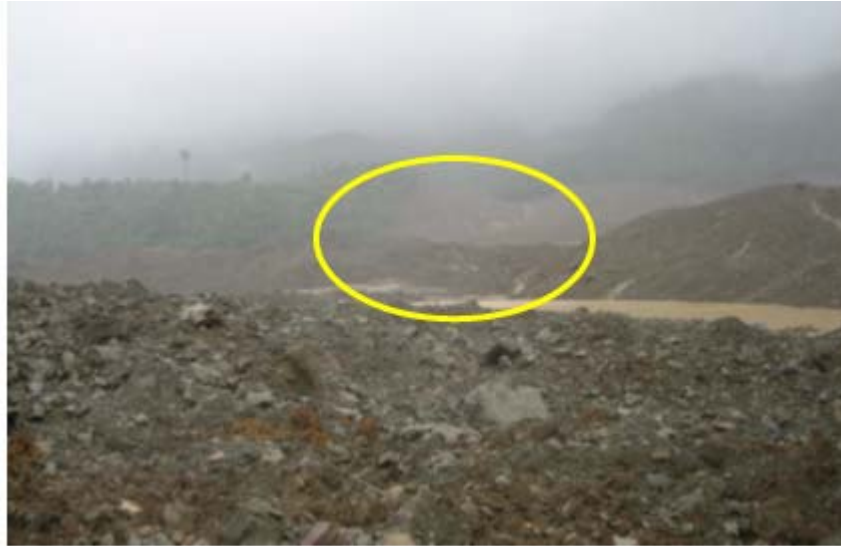
Figure 10 Surface Flow

The typical condition of the deposits was that the collapsed soil flowed down for more than a kilometer. Beyond 2 km and farther from the foot of the mountain, the slope is

almost flat exhibiting high water content and high fluidity, which makes it difficult to proceed from the rim to the mid-depositional area.

Deposits are composed of fine sediment, big boulders containing gravel and tuff breccia. Near the river, materials are fractured rocks which differ from other locations.
