Report on the Large-Scale Landslide at Mt. Bawakaraeng in Sulawesi

**JICA Urgent Survey Group
on the Large-Scale Landslide
at Mt. Bawakaraeng**

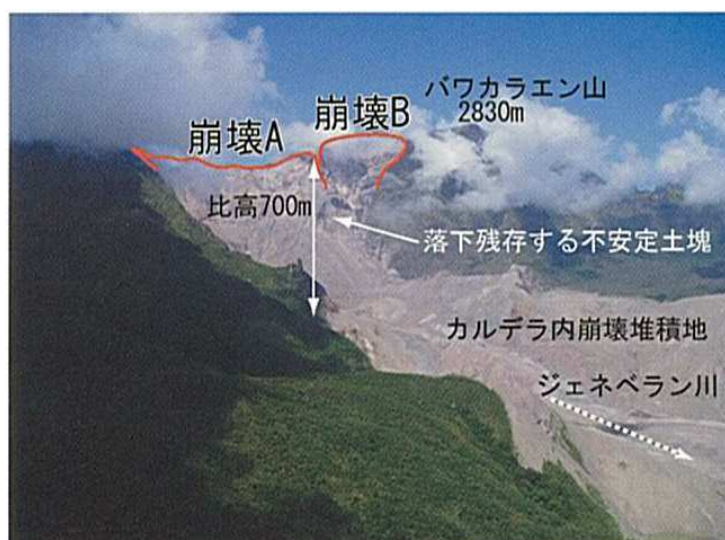
It is observed that an estimated 5 million m³ of soil mass, partly covered with vegetation, presumed to have fallen from the source section still remains in the center of the failure slope of Collapse B. This soil mass may lead to a secondary collapse if the lower end of it is eroded and made unstable.

The rock slope where the landslide occurred has not yet stabilized, with separation and fall of small-sized rock masses occurring constantly. It is judged that fallen rocks and debris are forming a talus around the foot of the slope surface. Also, unsteady rock masses that did not fall and those that fell from the upper ridge but did not fall further, are found on the slope. Therefore, it is still dangerous to come near the foot of the slope. According to local people, a difference in the ground level accompanying a large crevice existed around the ridge even before the occurrence of the landslide. From these situations at the site, the possibility of further collapse cannot be ignored.

Photo-1 Collapsed area seen from the ridge of caldera on the east side

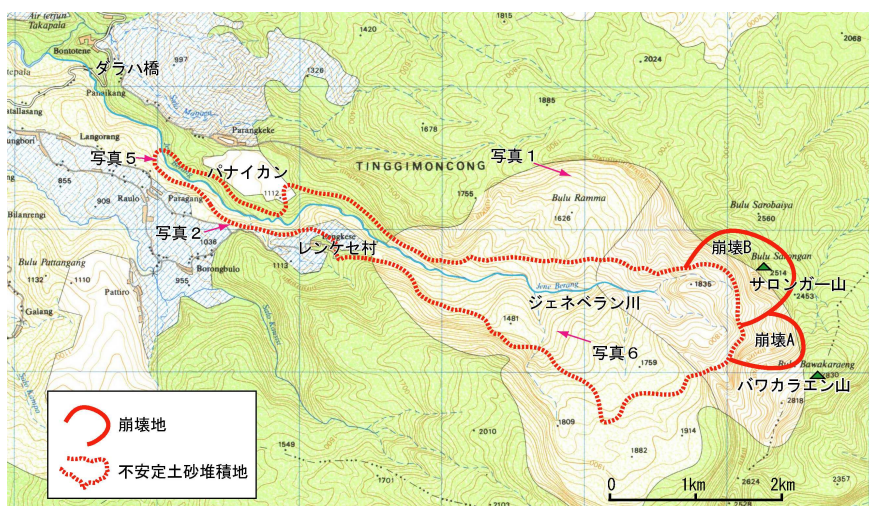
Around 13:30 on March 26, 2004, the inner side of the caldera wall at Mt. Bawakaraeng (elevation: 2,830 m) collapsed on a large-scale in the Province of South Sulawesi on Sulawesi Island in the Republic of Indonesia. An enormous amount of earth and debris ran down the slope and then accumulated for as long as 7 km along the valley. Two collapse areas are found at the source section of the landslide: one is a collapse with a width of 500 m that occurred near Mt. Bawakaraeng (Collapse A); the other is a huge collapse at the ridge of Mt. Sarongan, which occurred in a horseshoe shape for a horizontal length of about 1,300 m (Collapse B). The relative height of the failure slope in both collapses is about 700 m.

From visual observation, it is presumed that the thickness of failed bedrock in Collapse A was approximately 150 m. In the case of Collapse B, considering from the fact that the summit of Mt. Sarongan before the landslide was situated inside the caldera with a horizontal length of 400 m, it is inferred that the thickness of failed bedrock was about 400 m at the largest, and about 200 m on average (the average value is a little larger than that of Collapse A). From this, the amount of collapsed soil is estimated to be approximately 53 million m³ in Collapse A and about 182 million m³ in Collapse B, amounting to 235 million m³ in total.

Figure-2 Large-scale landslide at Mt. Bawakaraeng and the accumulated area of unstable sediment

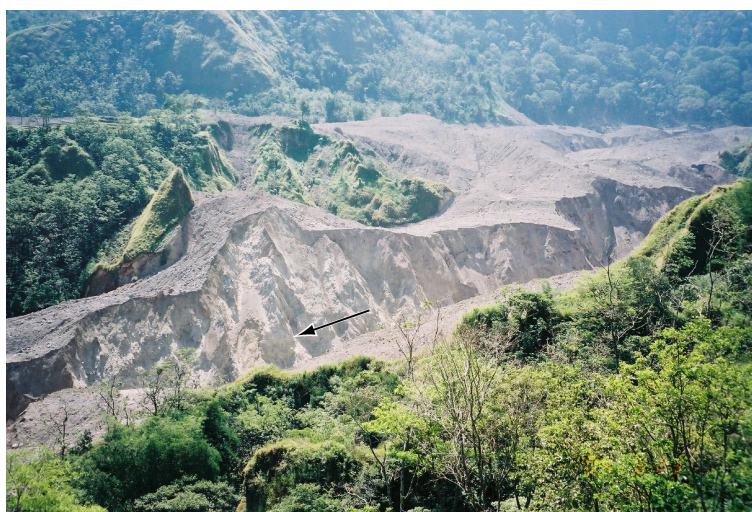
Nearly three months have passed since the landslide occurred on March 26 this year. In Indonesia, the dry season continues from March to October. The total rainfall during the three-month period observed at Malino, a rain gauge point closest to the failure site, was 388 mm, with no major rains. Even the rainfall exceeding a daily rainfall of 30 mm occurred only three times. However, the collapsed soil accumulated on the upstream of the Jeneberang River has already been eroded for 50~150 m in width and for 30~80 m in depth, forming a valley-like topography (Photo-2), and the erosion is considered to advance further. In addition, as this erosion valley is zigzag-shaped planarly, it will be

It is estimated that the amount of sediment discharge up to mid-June, 2004 was approximately 14 million m³ from the visual observation and a topographical map reading of the erosion valley. In the case of a sediment movement like the current case that occurred as a result of a large-scale collapse, sediment discharge is considered to decrease exponential-functionally as times passes. However, a continuous survey is needed.

Photo-2 Erosion at the accumulated area of collapsed sediment (sediment was accumulated after going over the plateau (Panaikang) in the back of photo)

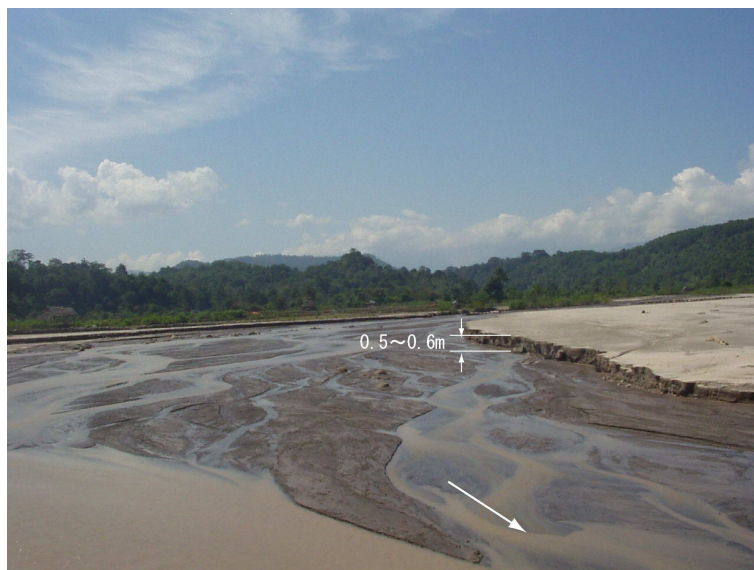
Six sabo facilities are situated along the river course of the Jeneberang River between the collapsed site and the Bilibili Dam, but they are all filled up with sediment. Especially, a large amount of sediment is temporarily accumulated at a sabo facility, 400 m wide, located at the downstream of the confluence point with the Malino River as well as in the river course above this facility. This indicates that a sediment control function and a river course adjustment function of the sabo facility are duly performed. The sediment overly accumulated in the river course is now being eroded (Photo-3), but no major indication of sedimentation is visible at the lower end of the reservoir of the Bilibili Dam. However, the Bilibili Dam that had been clear with blue water is now turbid with suspended sediment.

Photo-3 Sediment accumulated in the river course.

As the time is very limited until the rainy season comes in November, the executable structural measure (hard measure) in this period is the removal of sediment that has been accumulated above six sabo facilities along the river course in the section between the collapsed site and the Bilibili Dam. As the mid- to long-term measures, repair of damaged sabo facilities (Photo-4), rise of sabo dams, and construction of new sabo dams, are considered. It is also necessary to take measures to prevent the failure of a large pool of water located in the caldera, but it must be commenced after sufficiently confirming the safety of work, because there is a possibility that part of the caldera wall may fail.

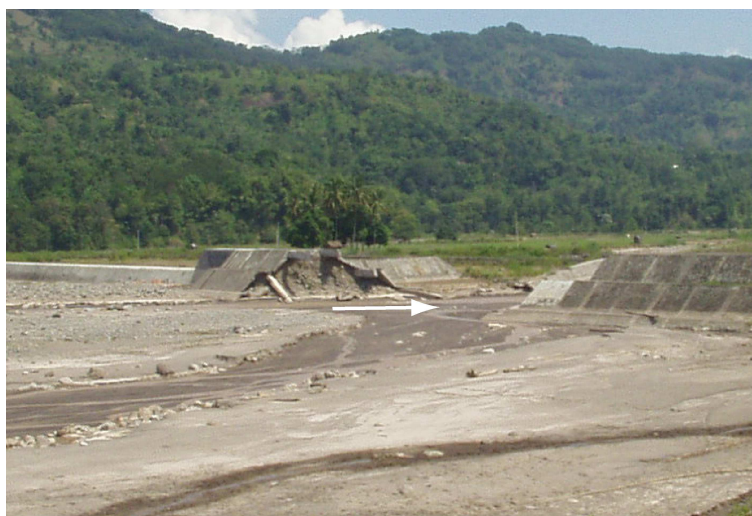
Photo-4 Sabo facility damaged by flooding
