Sediment-related disasters in the Off West Fukuoka Earthquake on March 20, 2005 (Preliminary report)

Land Conservation Division,
Sabo Department, River Bureau

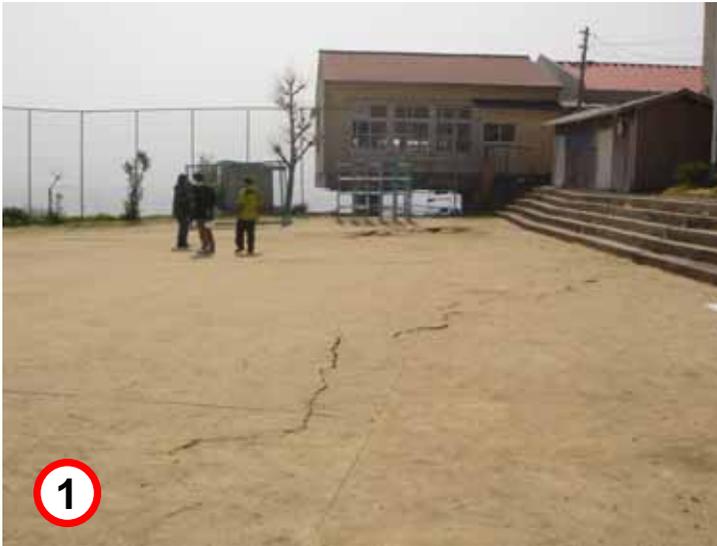
1

Cracking at the ground of Genkai Elementary School (pictured by an official of the KRDB on Mar. 21).

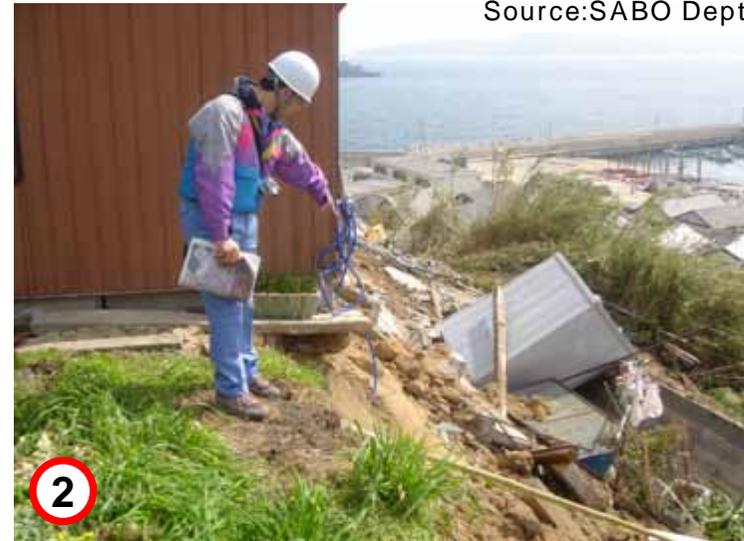
2

Slope failure in immediate proximity to houses (pictured by an official of the KRDB on Mar. 21).

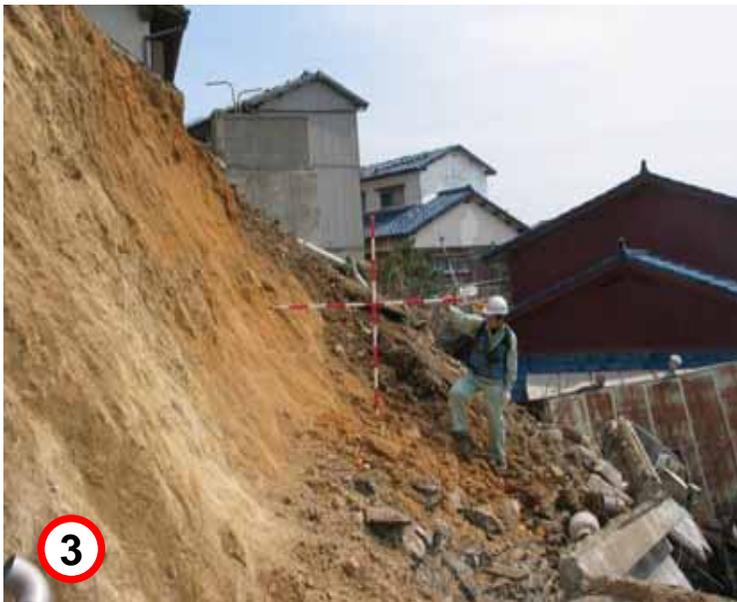
3

Slope failure in immediate proximity to houses (pictured by an official of the Fukuoka Prefectural Government on Mar. 21).

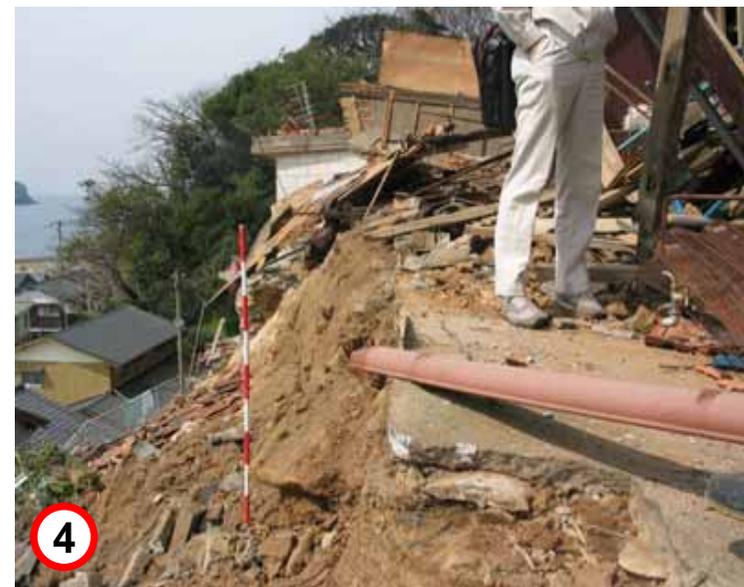
4

Slope failure in immediate proximity to houses (pictured by an official of the Fukuoka Prefectural Government on Mar. 21).
