State of sediment collapse

Change of landslide displacement at Higashi-Yokoyama along the Ibi River
(measurement: extensometer)

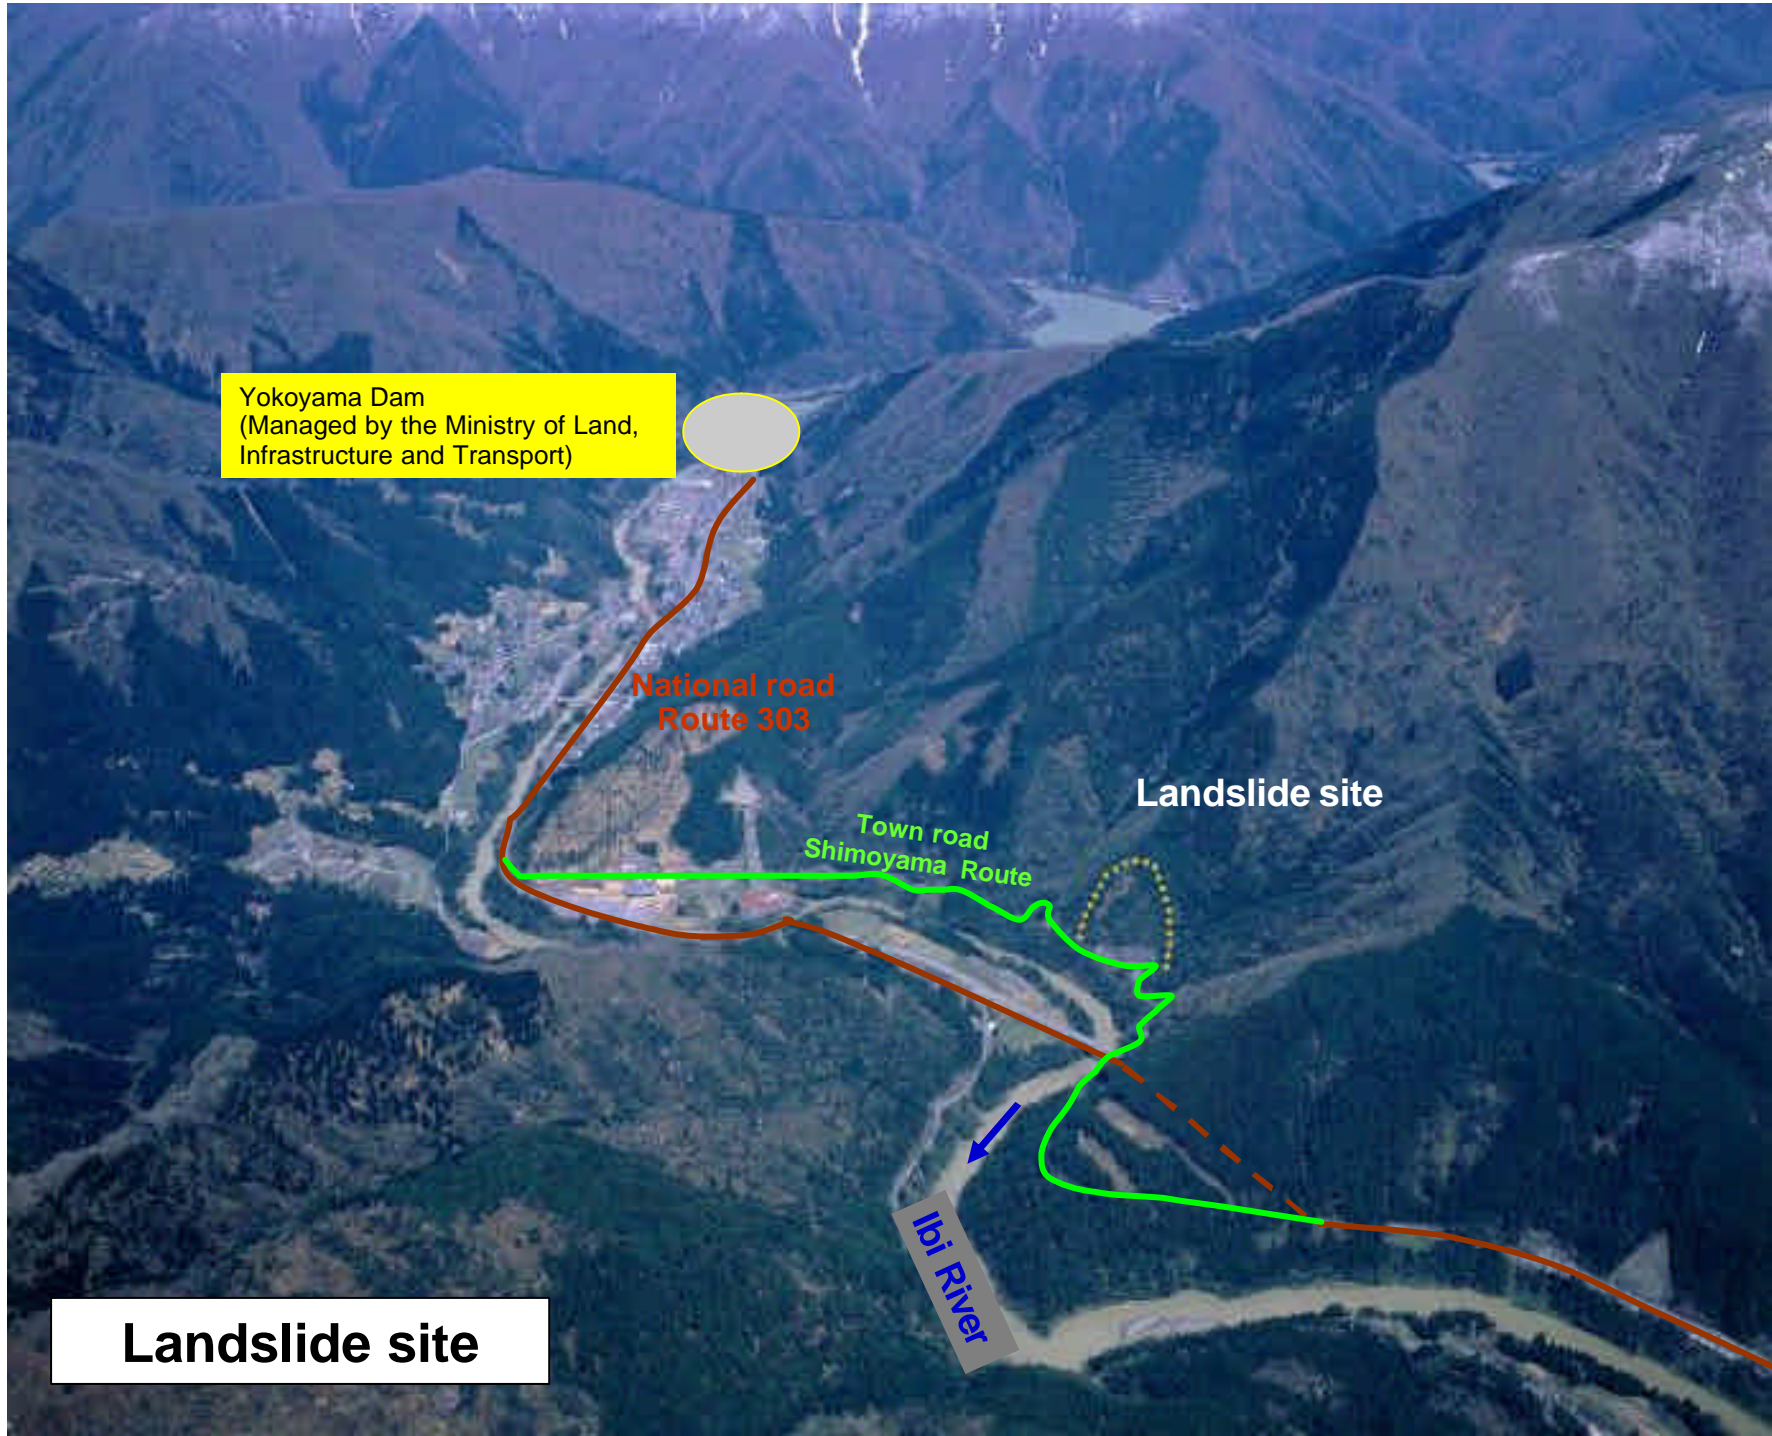
Yokoyama Dam
(Managed by the Ministry of Land,
Infrastructure and Transport)

Landslide site

Ibi River

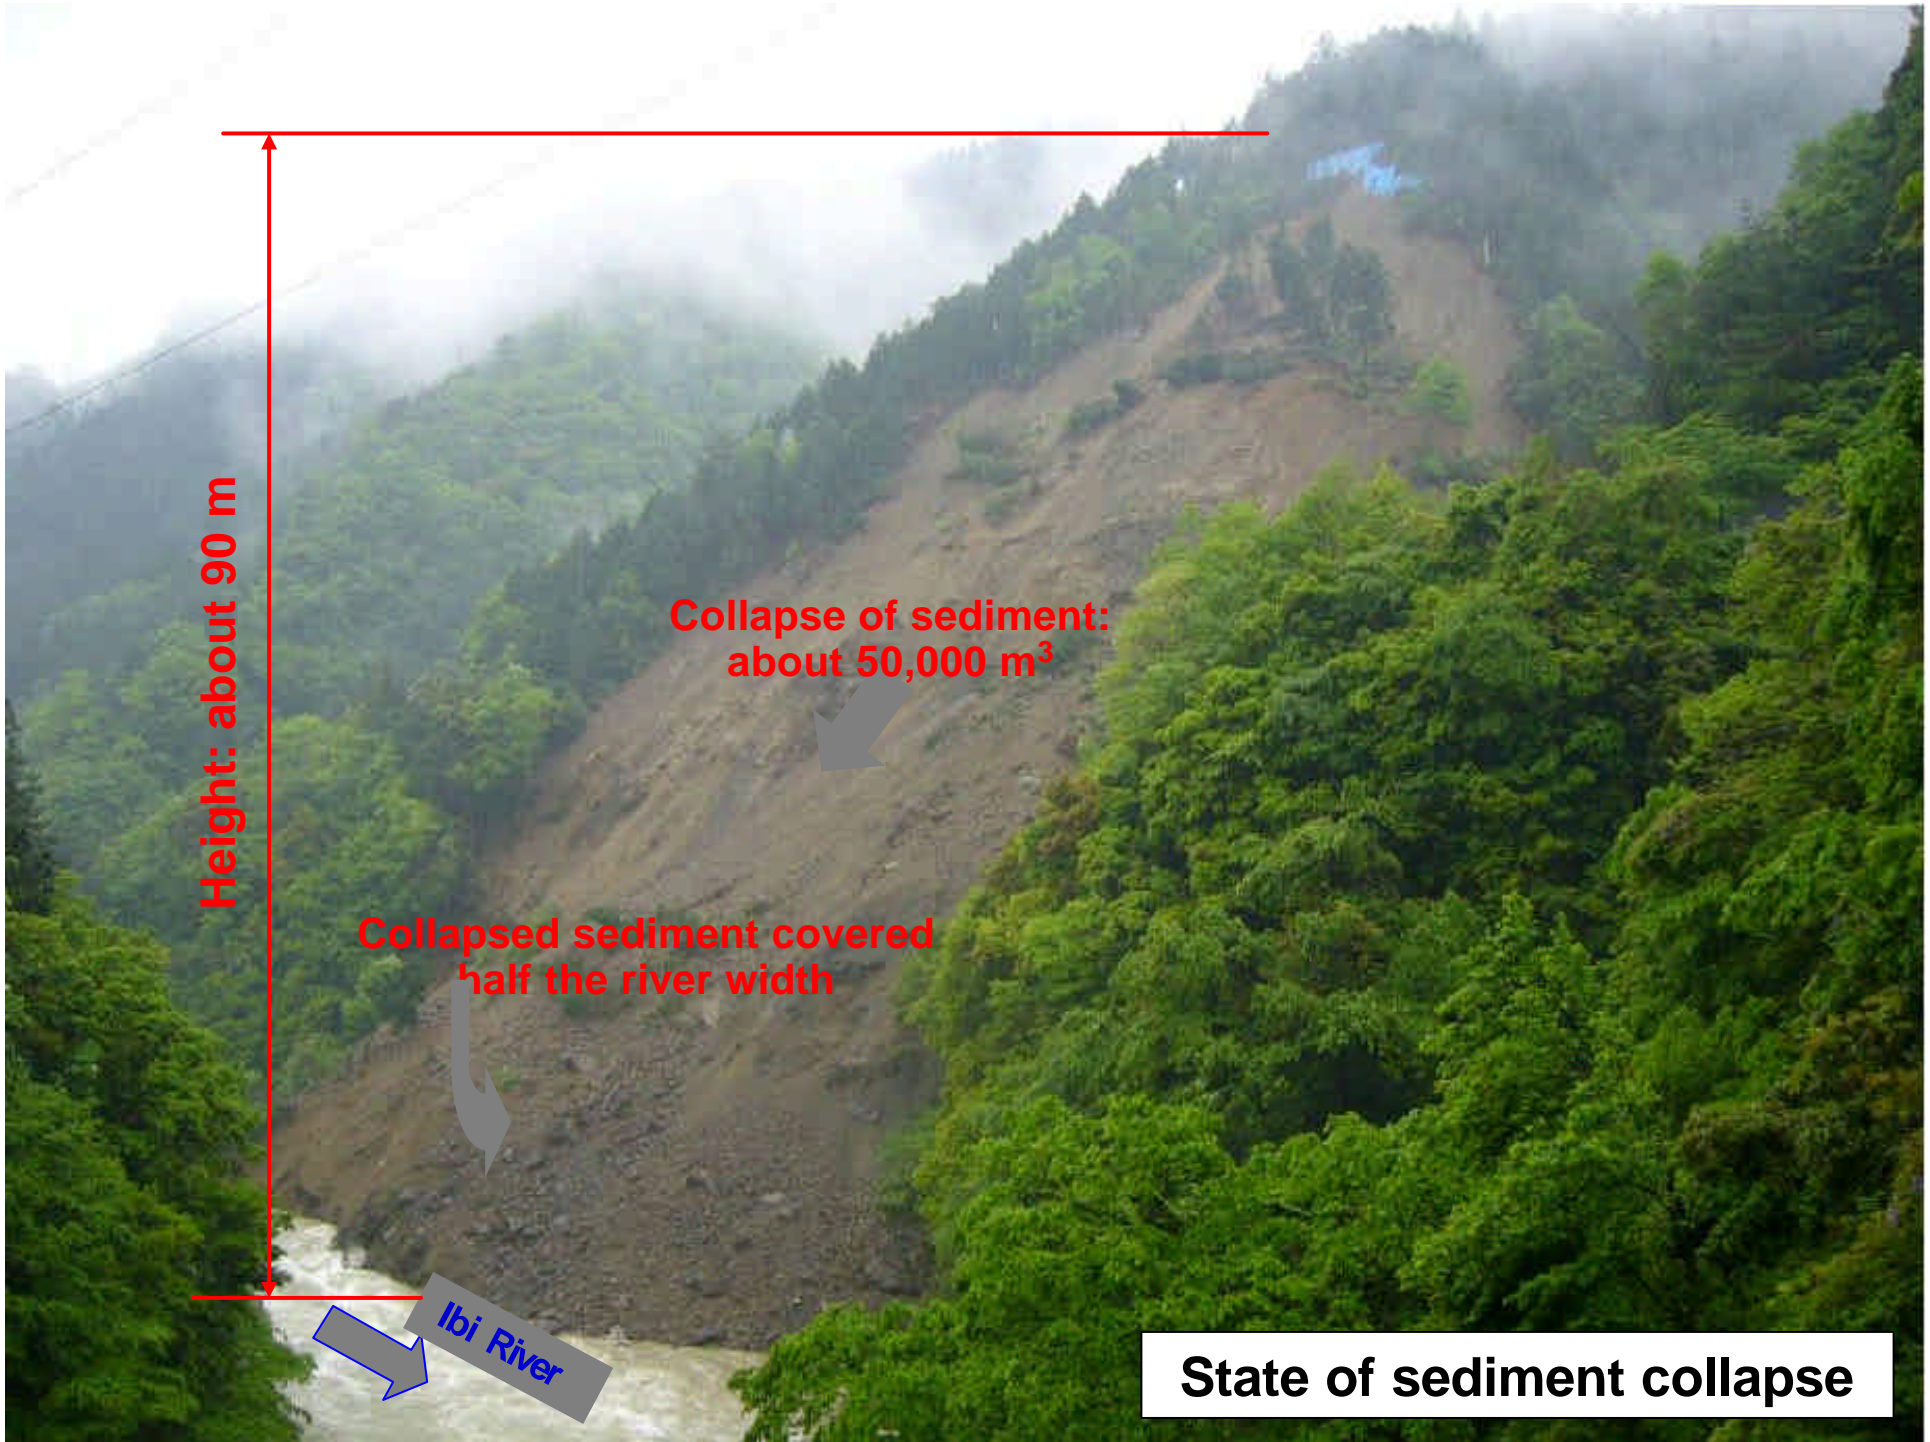
Height: about 90 m

Collapse of sediment:
about 50,000 m³

Collapsed sediment covered
half the river width
