# Large-scale collapse at the Kakkonda Geothermal Power Station in Shizukuishi Town, Iwate Prefecture

**Location:** Kakkonda Geothermal Power Station near the Kakkonda River of the Kitakami river system in Shizukuishi Town, Iwate Prefecture

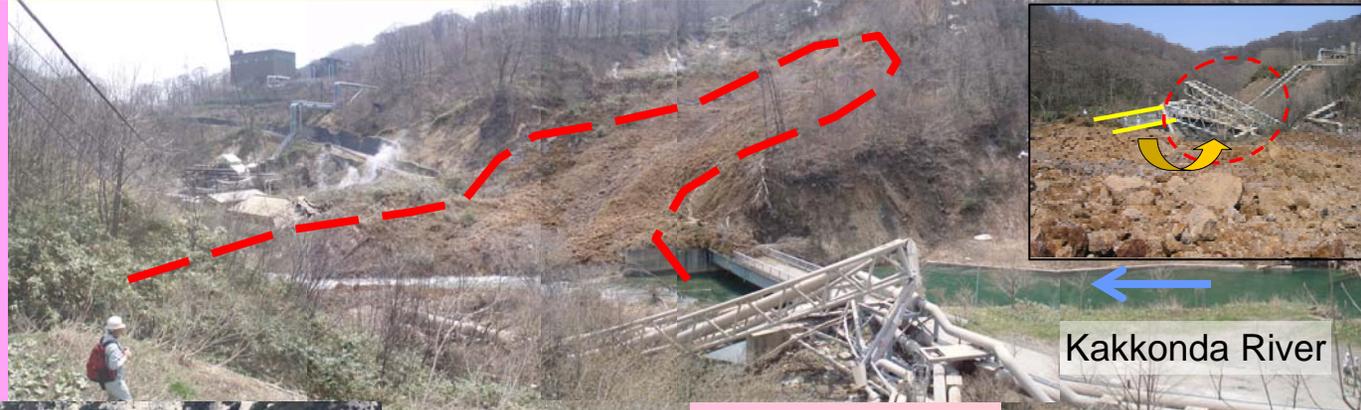
## State of damage

**Damage:** Partial failure of the power station facility (under suspension), blockage of the prefectural Nishiyama-Ononai road

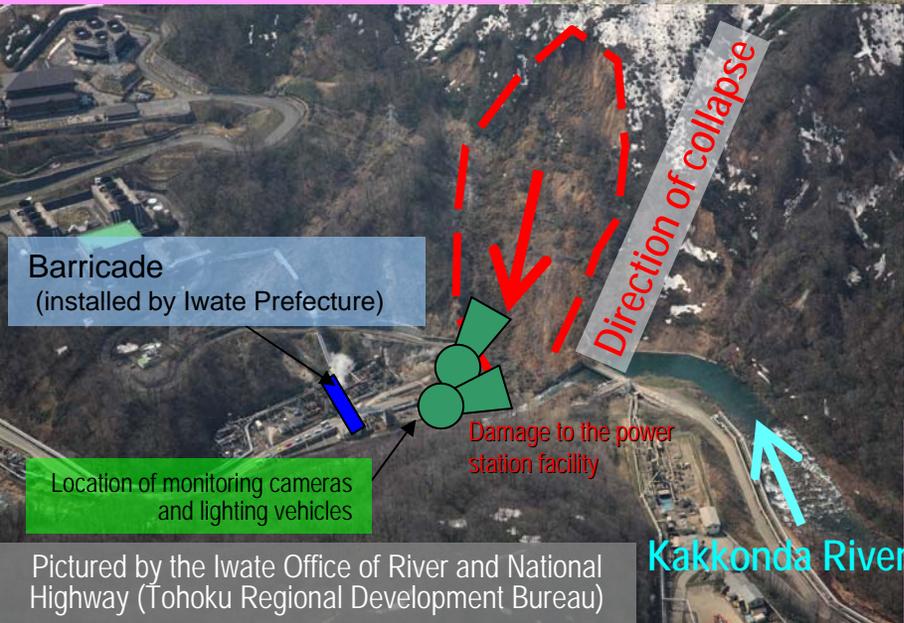
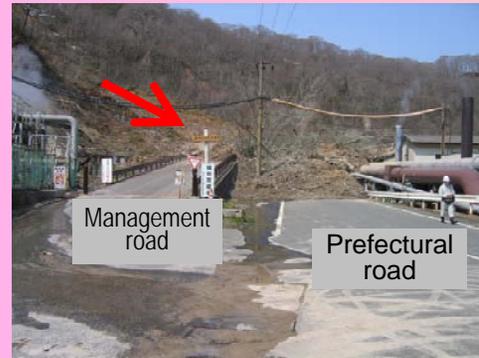
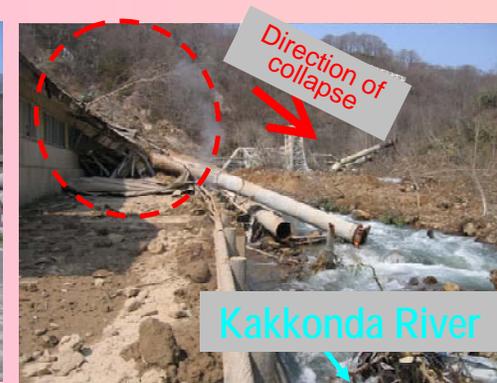
**Scale** ca. 200 m long, 100 wide, 3 m deep; **Sediment volume:** ca. 60,000 m<sup>3</sup>

Pipes of the power station distorted by sediment
