## Typhoon Disaster in Taiwan in August 2009

This report has been prepared by Mr. Toru TAKAHASHI, Technical Advisor of Dia Consultants Co., Ltd., who took part in the Taiwan-Japan Sabo Joint Research as a member of the Japanese research group between October 11 and 17, 2009.

### 1. Overview of disaster caused by Typhoon Morakot

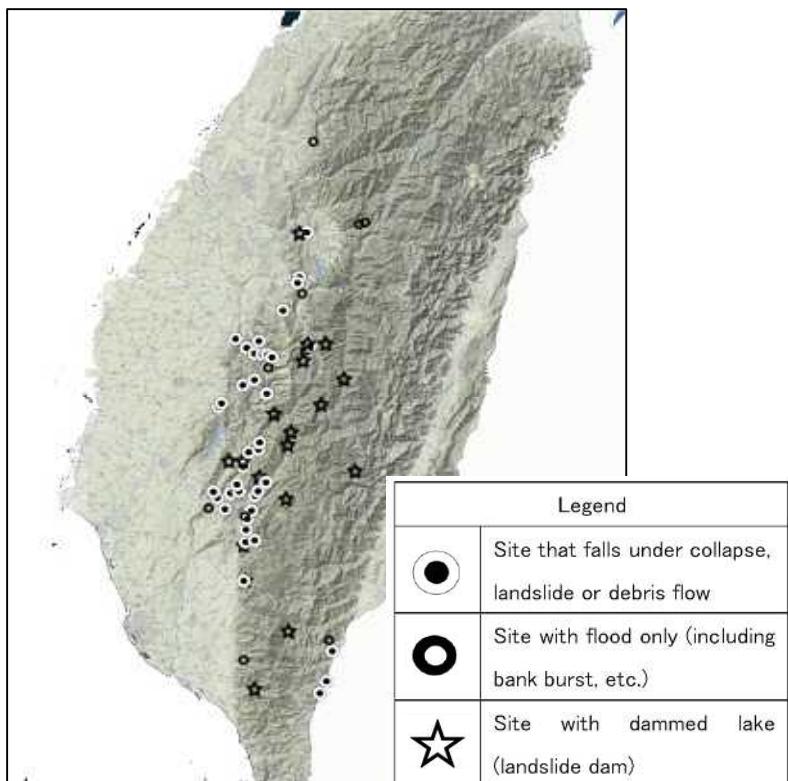
Figure-1: Major sites of sediment-related disasters caused by Typhoon Morakot

On major sediment-related disaster sites that suffered human and general damage, the Soil and Water Conservation Bureau published a preliminary report, which says that the number of sites was 52 in total, and the Forestry Bureau has reported that the number of dammed lakes (landslide dams) caused by the downpours was 18 in total. However, satellite images taken after the disaster suggest that, on top of them, even more collapses and debris flows occurred in forestland deeper in the mountains.

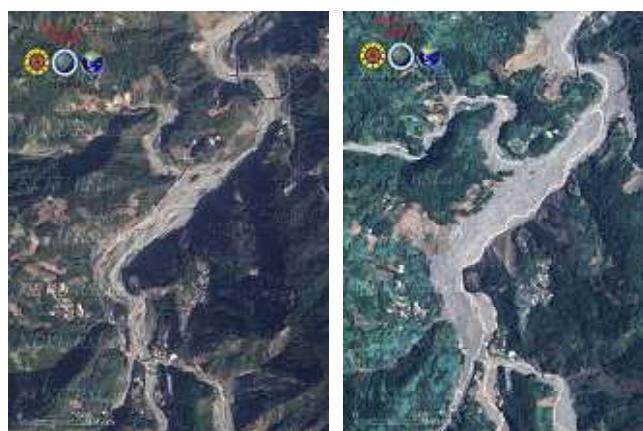
Figure-3: Satellite images before (left) and after (right) the disaster

The enormous downpour due to the typhoon caused collapses here and there on the mountainside in the upper reaches and the three branches generated massive debris flows down to the confluence into Hoshe River before the dawn of August 9 and large amounts of sediment deposited near the confluence where houses and Shenmu Elementary School were located, the thickness of which reached 20 m. Although no human damage was caused, the flows of the sediment destroyed Route 21 and the industrial road over approximately 600 m.

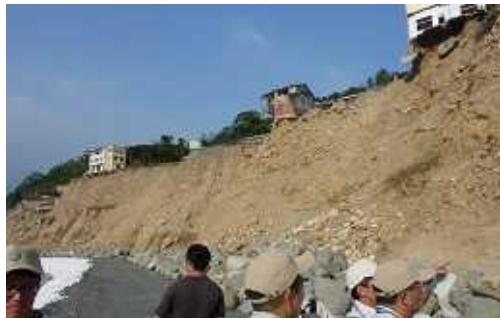
Photo-1: Tremendous bank erosion

In addition, Longhua Elementary School (built after being struck by Chichi Earthquake in 1999) and about 20 houses suffered serious damage with their foundations washed away due to bank erosion.

Furthermore, in the lower reaches of Chenyulan River near the confluence into the main stream of Jhuoshuei River, bank scouring and erosion washed away the foundations of Route 21 and houses along the road, which indicates the furiousness of the flood flow.

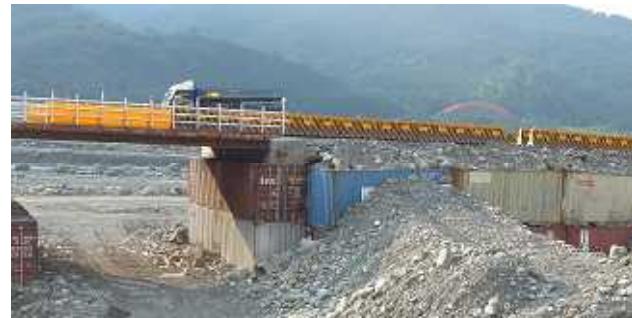
Photo-2: Temporary bridge abutments making use of container boxes

The restoration of damaged roads was quick including well-thought-out restoration work such as bridge abutments making use of container boxes and pier foundations.

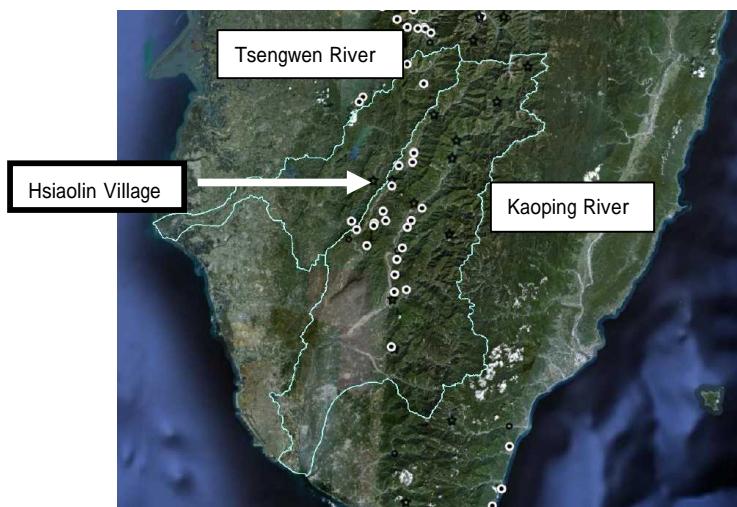
Figure-4: Tsengwen River and Kaoping River

Hsiaolin Village had a community with 184 households on a small terrace surface on the left bank in the upper reaches of Chishan River, a branch of Kaoping River. Residents who managed to survive the disaster say that a large collapse of the slope behind the village occurred in early morning at 6:00 of August 9, which buried most of the village, and the landslide dam that formed due to the collapse burst between 6:00 and 8:00, causing a flood that swept away and completely destroyed the village and claimed more than 450 lives in a moment.

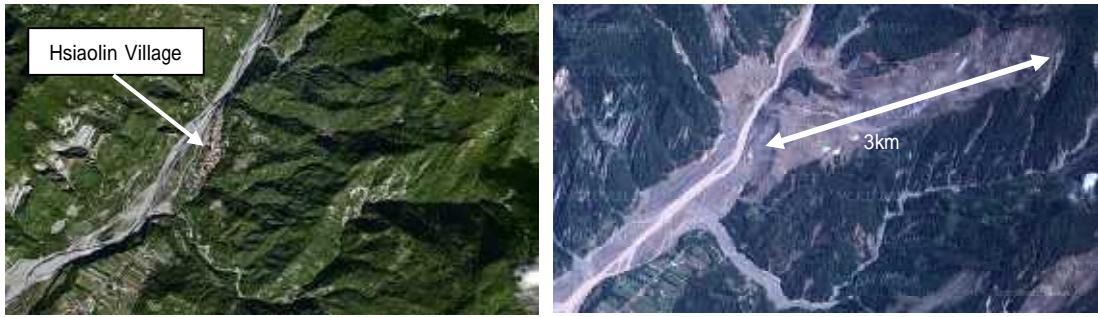
Figure-5: Satellite images before (left) and after the disaster in Hsiaolin Village

According to the data provided by the Taiwanese group, it has been estimated that the area of the large collapse on the left bank of Chishan River that directly struck the village was approximately 350 ha (of which the range of collapse was 190 ha with the maximum width at 1.2 km and maximum flow distance at 3 km, the maximum depth of collapse was 80 m and range of sedimentation was 160 ha), the relative elevation difference was approximately 900 m and the total amount of collapsed sediment was around 10 million m<sup>3</sup>. A large landslide collapse occurred also on the right bank across Chishan River, the sediment from which was combined with the sediment washed down due to the large mountainside collapse on the left bank dammed up Chishan River and formed a landslide dam that seems to have burst soon. Of the 184 households in the community, only two survived.

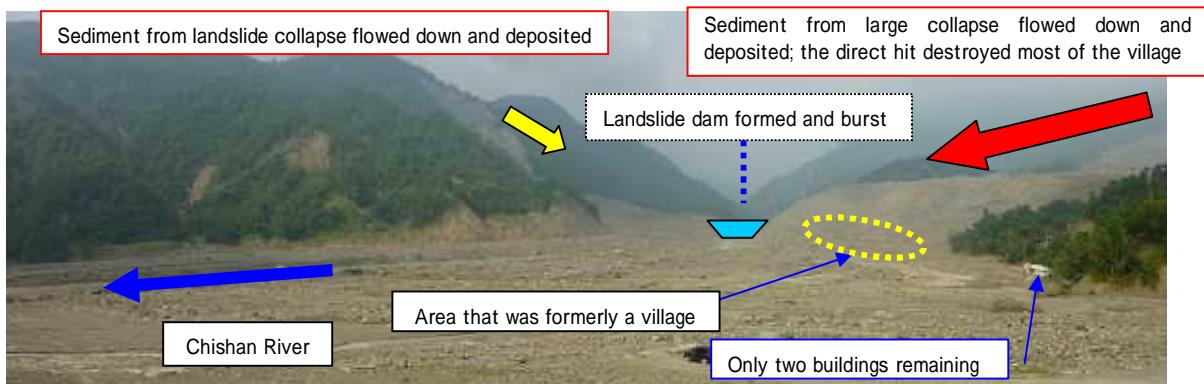
Photo-3: Conditions of site in Hsiaolin Village (overlooking the upper reaches of Chishan River; head of the collapse totally unobservable from the riverbed)

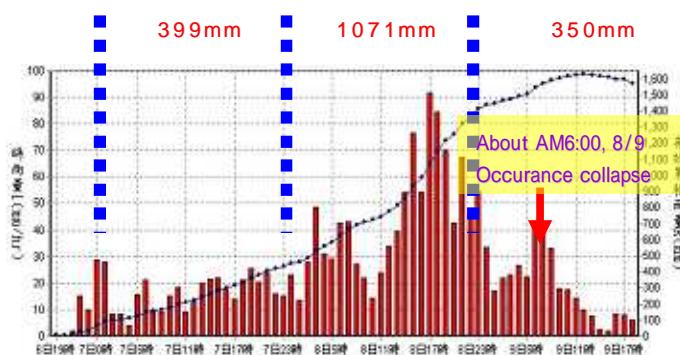
Figure-6: Rainfall graph (Chiahsien Observatory)

Based on the data obtained by the Central Weather Bureau Chihsien Observatory, the daily rainfall on the previous day August 8 until the occurrence of the large collapse was 1,071 mm (in excess of the rainfall of a 200-year probability of 904 mm) and the cumulative rainfall from August 7 to the occurrence of the collapse on August 9 was approximately 1,500 mm, which is an extraordinary downpour. This caused such a large-scale sediment-related disaster.

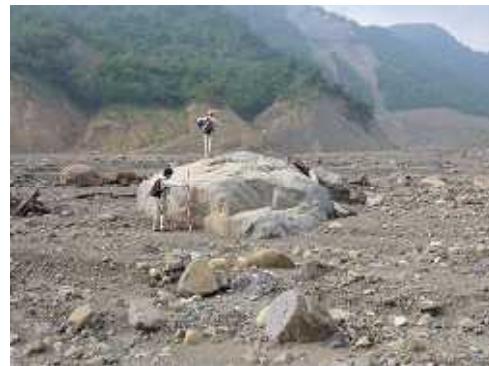
Photo-4: Gigantic stone apparently caused by a collapse

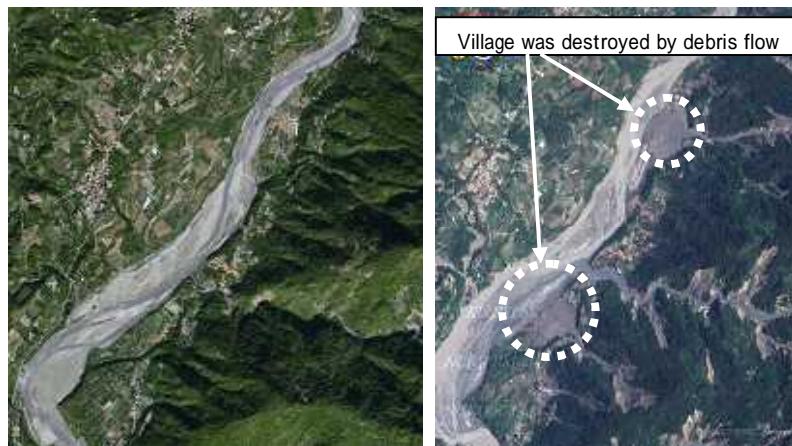
Figure-7: Sinkai Village and Sinfia Village with their communities engulfed by a debris flow (left: before the disaster)

An explanation was given that, on top of the two sites with an entire community completely destroyed by a debris flow, the state of dilapidation in the basin was striking and, within the scope of the present field investigation conducted, this Laolong River Basin suffered more incidents of collapses and debris flows than the entire Chishan River Basin (except for Hsiaolin Village) and a huge amount of sediment flowed into and down the river channel of the main stream.

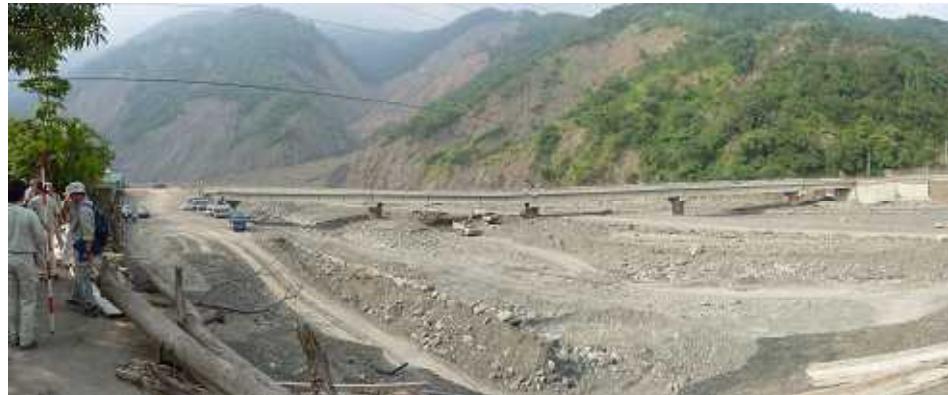
Photo-5: River conditions near Paolai Village in the middle- to upper reaches of the Laolong River Basin

In Paolai Village in the uppermost reaches of the Laolong River Basin accessible by car and investigable, the group visited a fire station with flood marks caused by the breach of the landslide dam

remaining on the wall and obtained a valuable testimony from a young female fire chief that a large flood apparently caused by the burst of a dammed lake upstream hit the site on August 11 after the rainfall stopped.
