Sediment-related disasters caused by snowmelt in 2005 (quick report) (as of May 13, 2005)

Land Conservation Division,
Sabō Department, River Bureau

Sediment-related disasters caused by snowmelt at the damage sites of the Chuetsu Earthquake

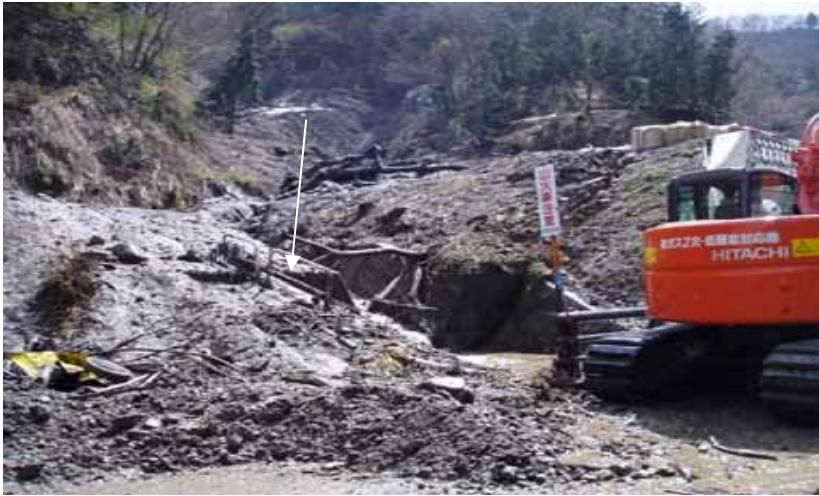
[April 23, 2005: hillside collapse]
 Place: Nigorizawa area, Nagaoka City, Niigata Prefecture
 Damage: A hillside collapse occurred in the area of 100 m wide and 300 m long. Sediment flowed out to the Kashiwazaki-Takahama-Horinouchi line of the prefectural road, closing to traffic temporarily.

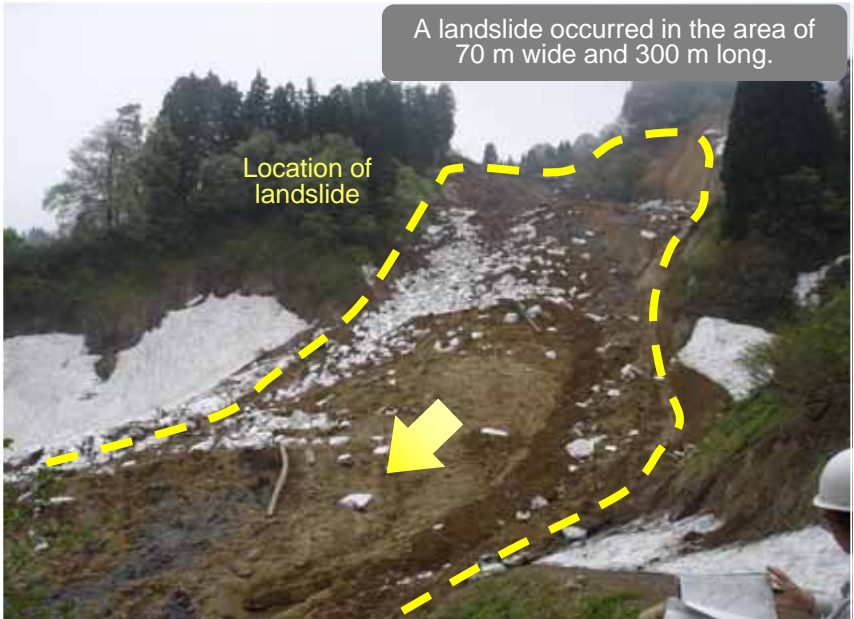
[May 10, 2005: landslide]
 Place: Urada area, Tokamachi City, Niigata Prefecture
 Damage: A landslide occurred in the area of 70 m wide and 300 m long. The Toyoda River (sabo river) was clogged with sediment.

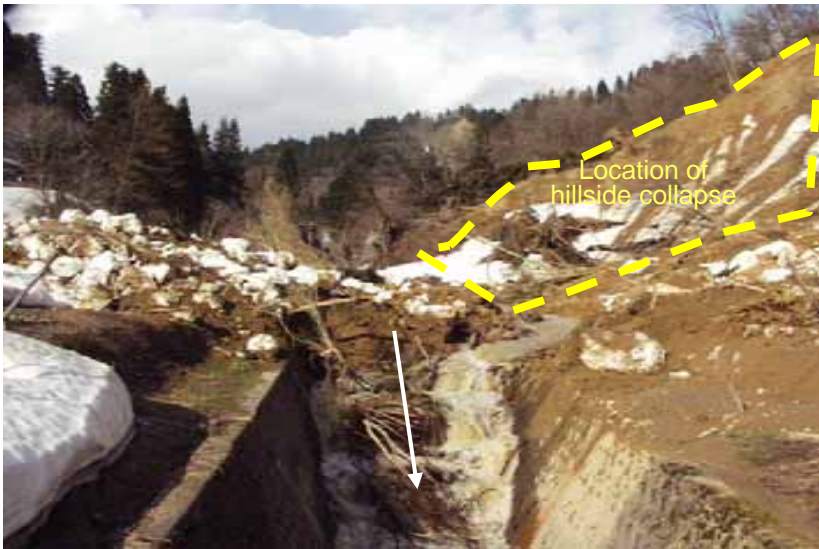
[April 23, 2005: hillside collapse]
 Place: Kizawa area, Kawaguchi Town, Niigata Prefecture
 Damage: A hillside collapse occurred in the area of 250 m wide and 70 m long. The channel of the Class A Matsuzawa River was clogged.

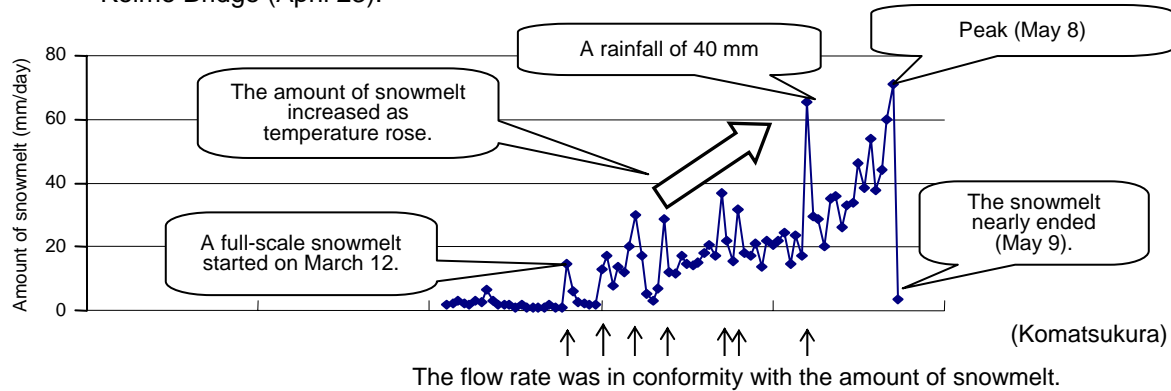
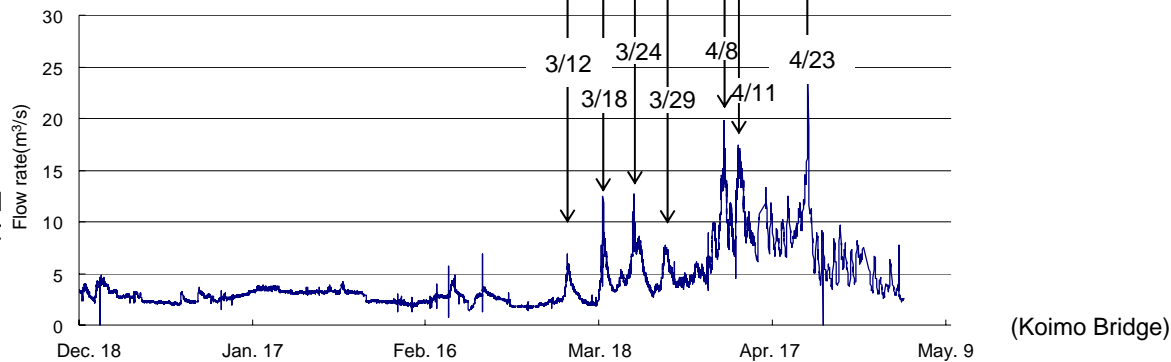
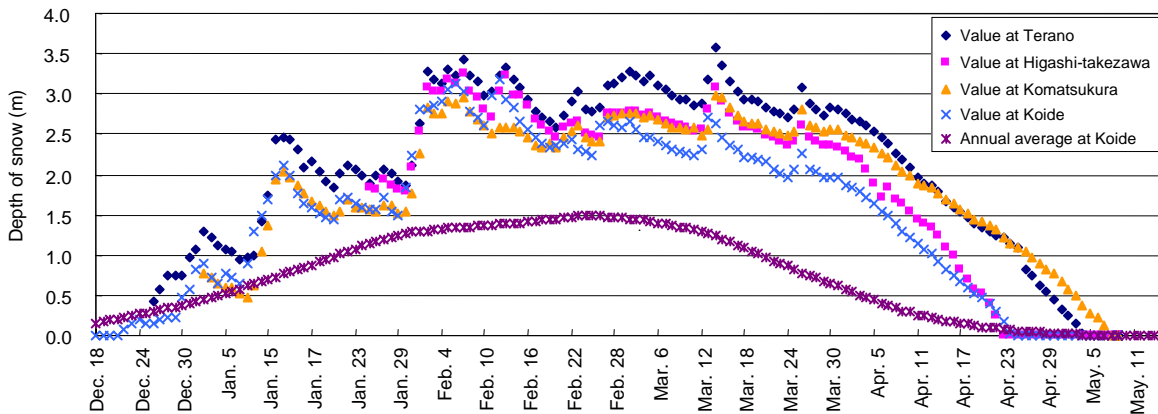
Snowmelt in the Imo river basin (analytical results by the Erosion and Sediment Control Research Group of the Public Works Research Institute)

- The snowmelt in the Imo river basin nearly ended by early May.
- The maximum flow rate in the Imo River was approximately 24 m³/s at the Koimo Bridge (April 23).

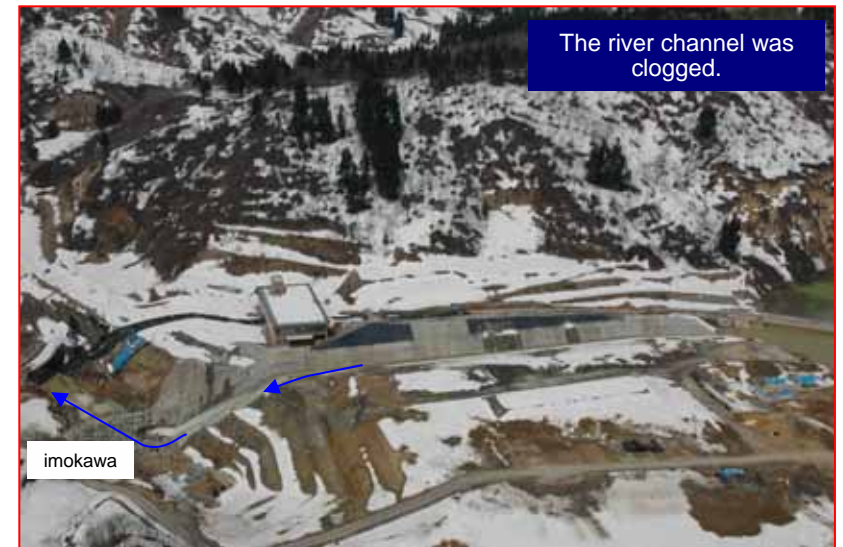
○ Snowmelt gauging point in the Imo river basin

Nagaoka City, Niigata Prefecture (Higashi-takezawa area of the former Yamakoshi Village) (Photographed on May 12, 2005)
