Sediment-related disaster

<Downpour by seasonal rain front>

Land Conservation Div., Sabo Dept.,
Ministry of Land Infrastructure and
Transport
2 Aug., 2006

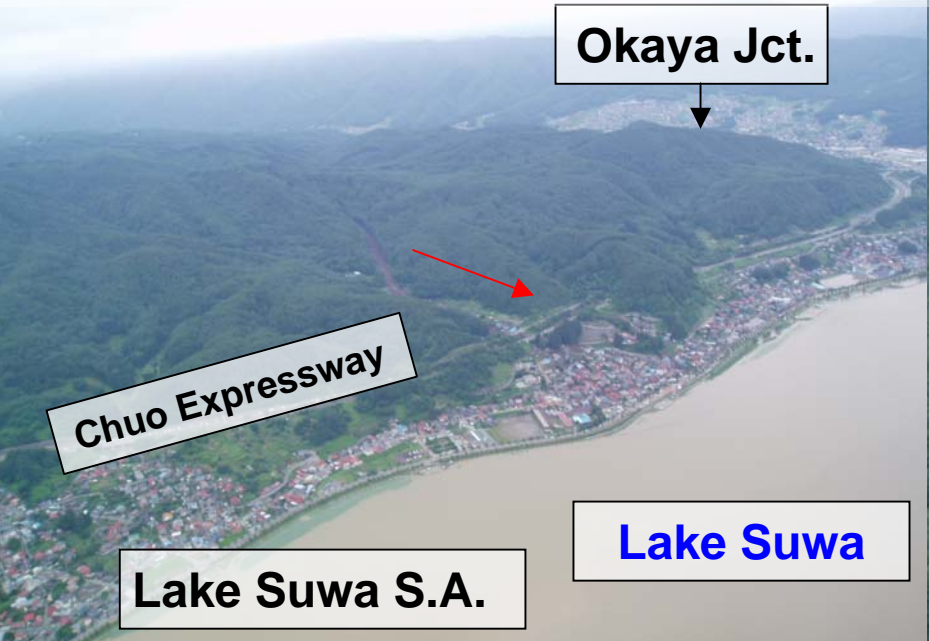
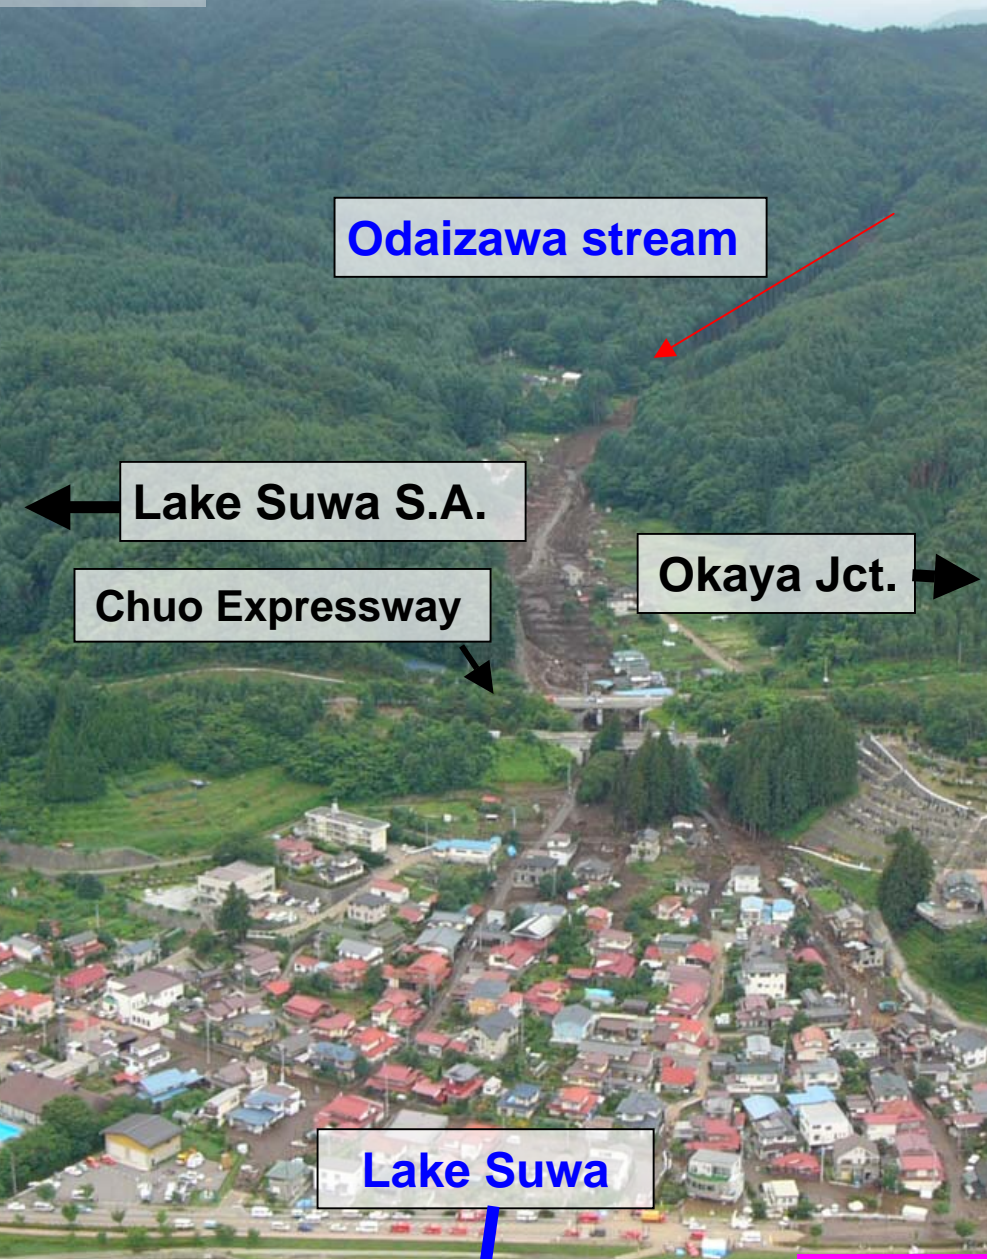
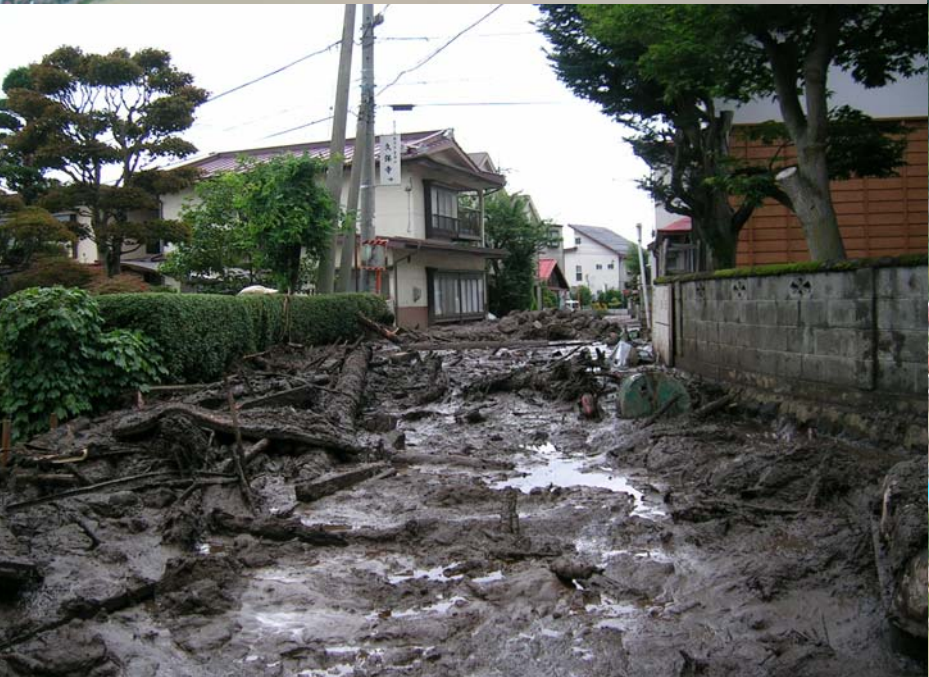
7 dead (debris flow):
Minato 3 chome, Okaya City, Nagano Pref.

There were no facilities like Sabo dam

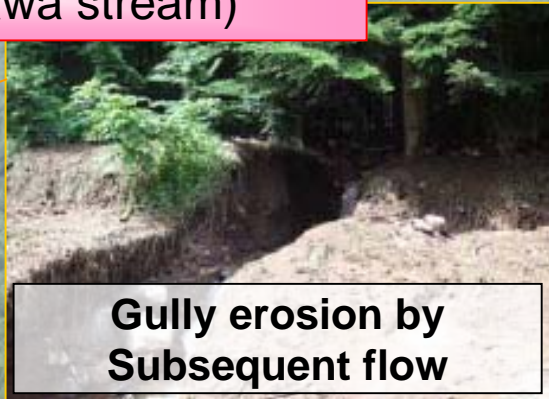
Gully erosion by Subsequent flow

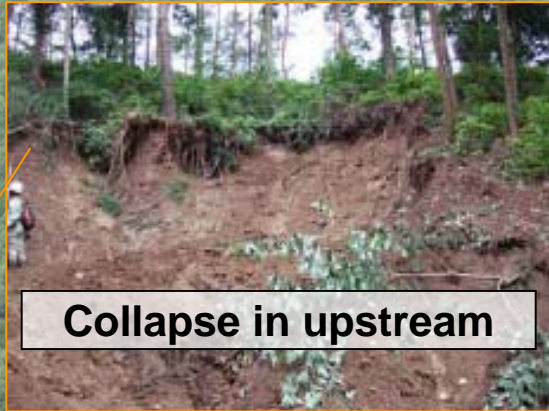
Collapse in upstream

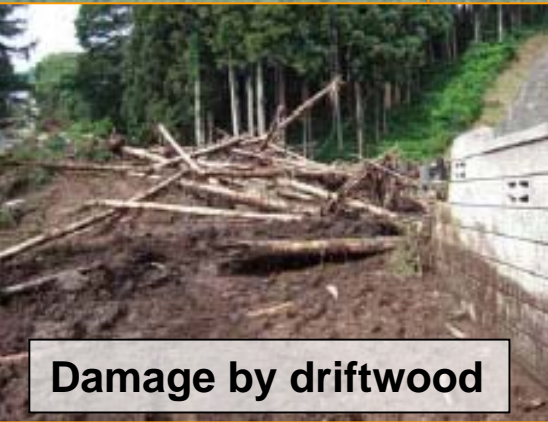
Damage by driftwood

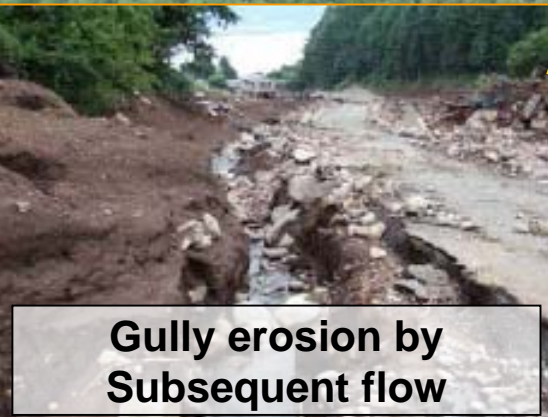
Gully erosion by Subsequent flow

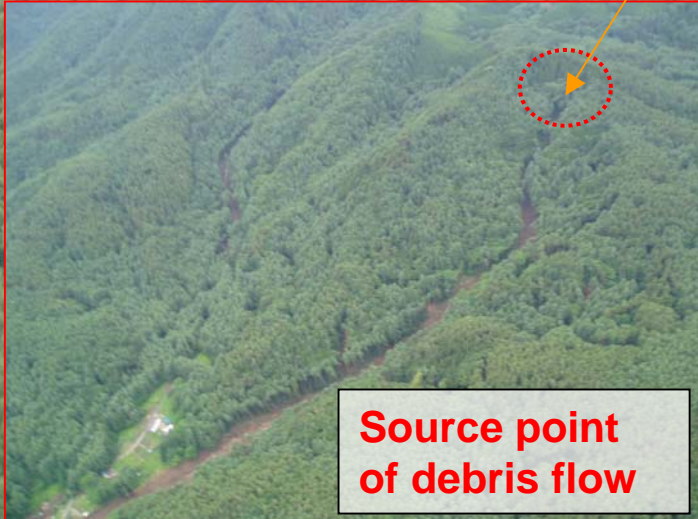
Odaizawa stream

Source point of debris flow

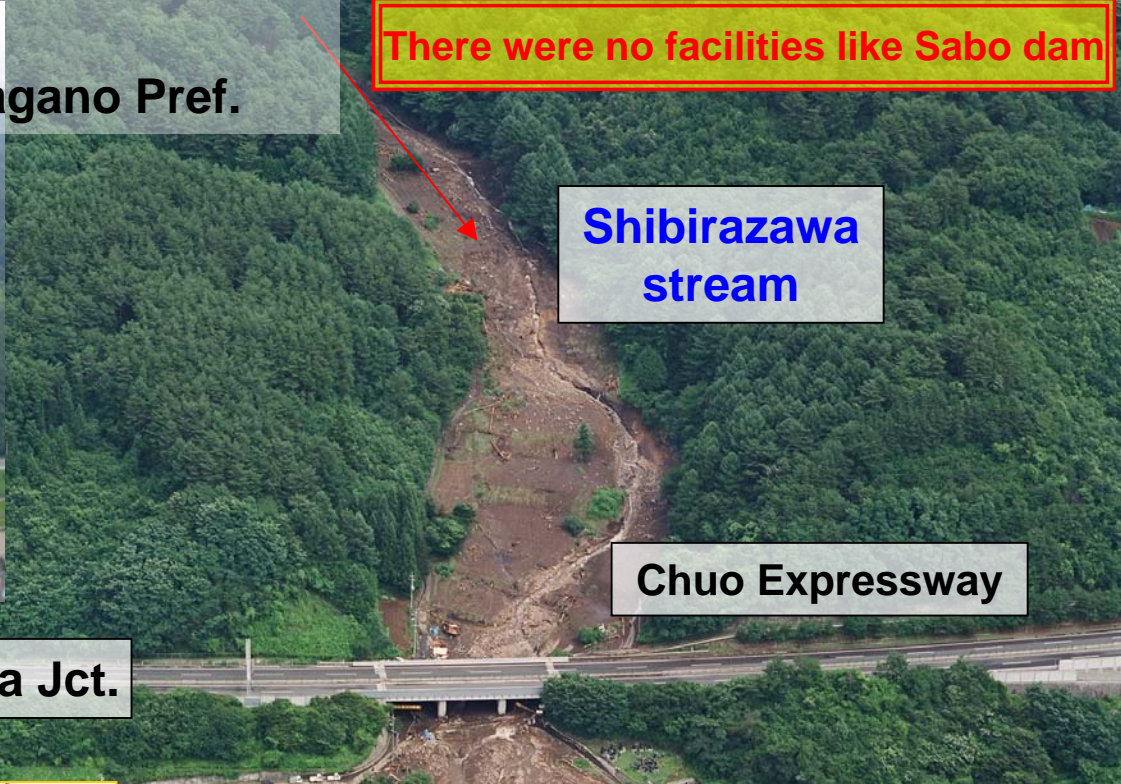
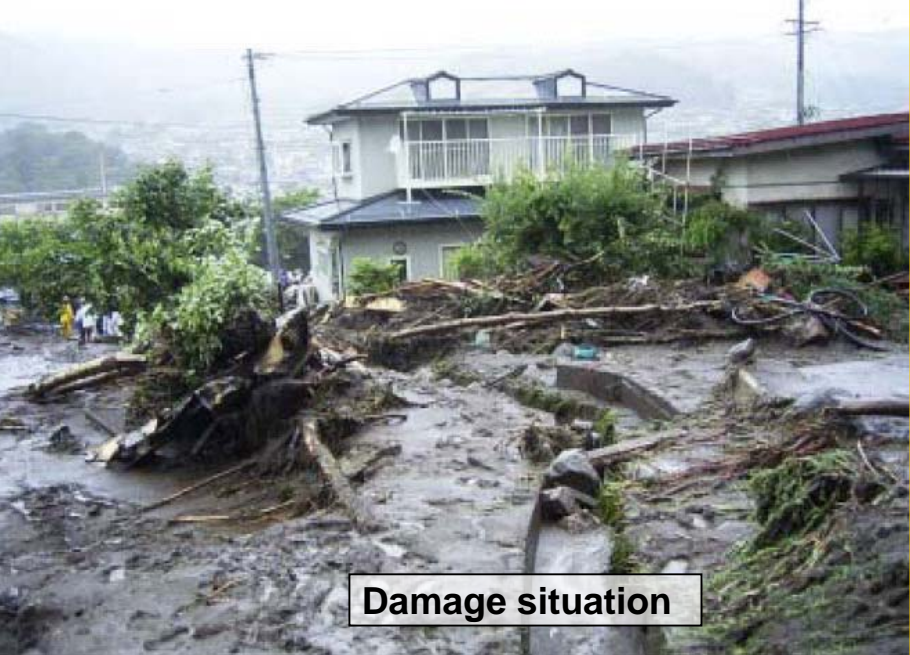
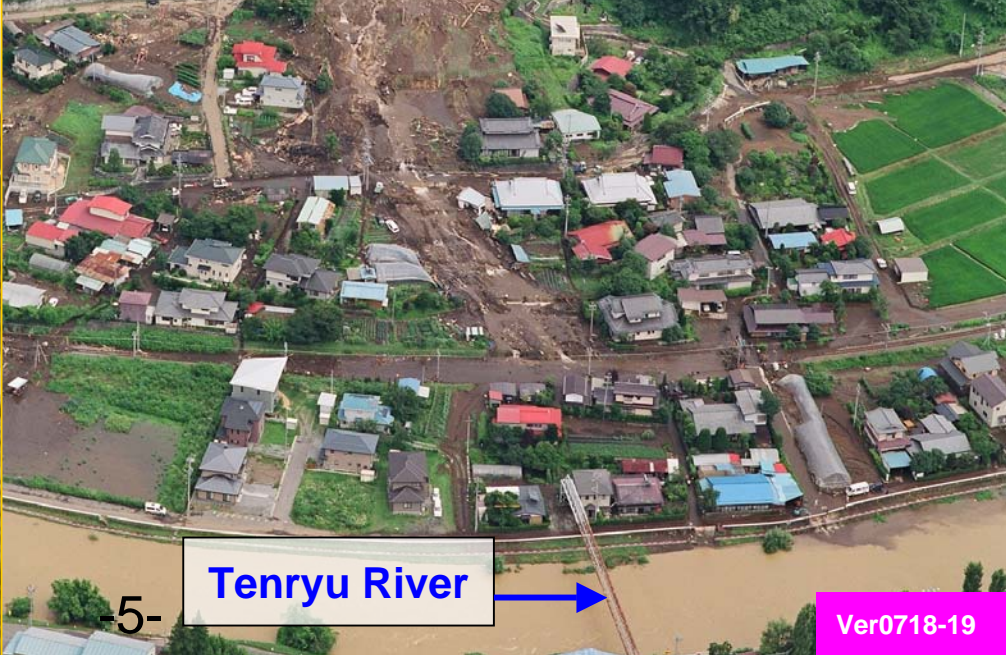
1 dead (debris flow):
Kawagishi-higashi, Okaya City, Nagano Pref.

There were no facilities like Sabo dam

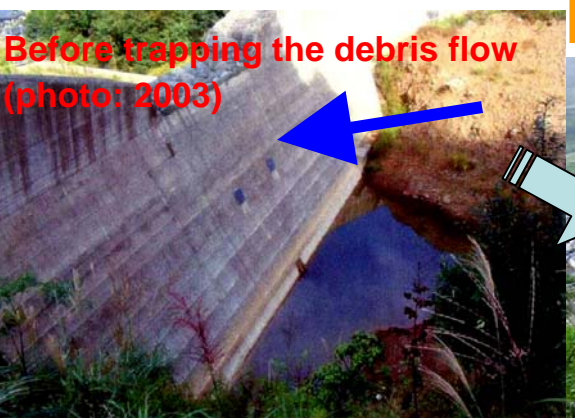
Before trapping the debris flow (photo: 2003)

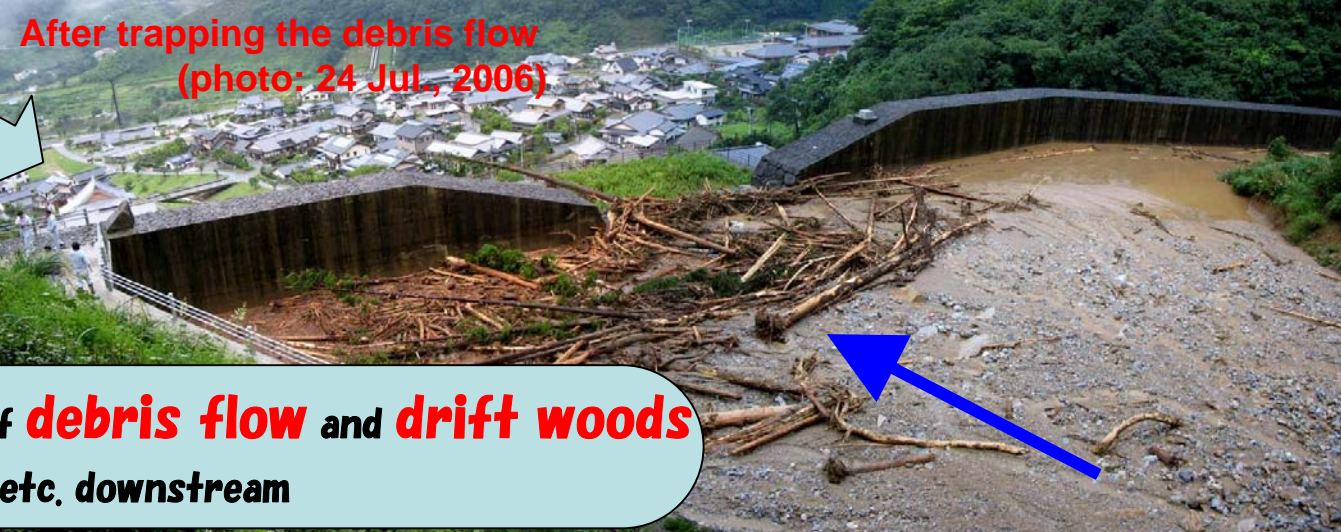
After trapping the debris flow (photo: 24 Jul., 2006)

- Trapped about 6,000m³ of debris flow and drift woods
- No damage to houses etc. downstream
