# Landslide Dam formed in Kawarada river in Ishikawa Pref.

March 25, 2007

Sabo Dept., MLIT

Place: Kumano, Wajima-City, Ishikawa Pref.

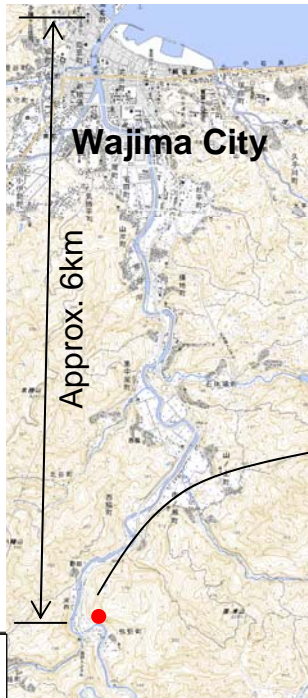
Outline: Landslide dam formed naturally in 6km upstream from city area.

Dam was formed by slope failure occurred by earthquake at 10:50 am on March 25, 2007. Width of the failure is 30m and its height is 40m.

Wajima City Office has carried out emergent excavation to keep cross section for 5m width at 12:00 am. After excavation, water depth keeps up to 1m.

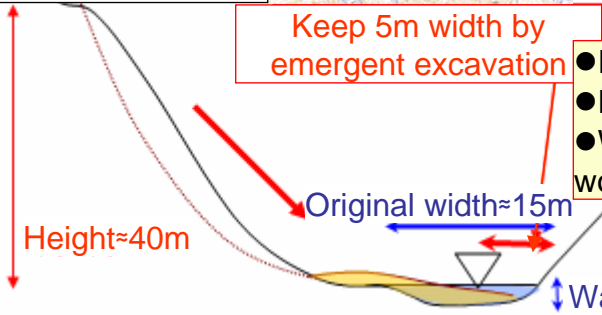
X-section

- River blocked by collapse, and naturally dammed up
- Debris was removed to keep 5m cross section for flow
- Water depth in upstream side is about 1m, no harm would be for inundation in residential area.

Water depth≈1m Under investigation
