# Sediment and flood damage, and driftwood disaster in Tsukada River (Wajima City) caused by the extreme rainfall in September after the Noto Peninsula earthquake

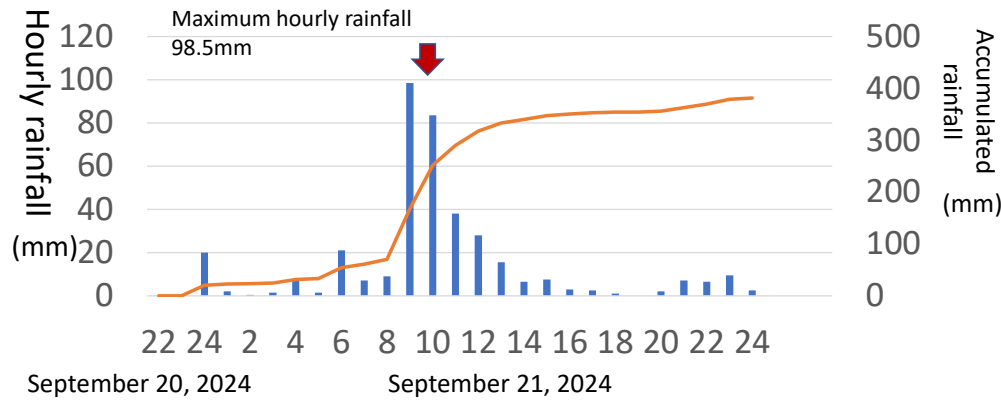
Hourly and accumulated rainfall at AMeDAS Waji

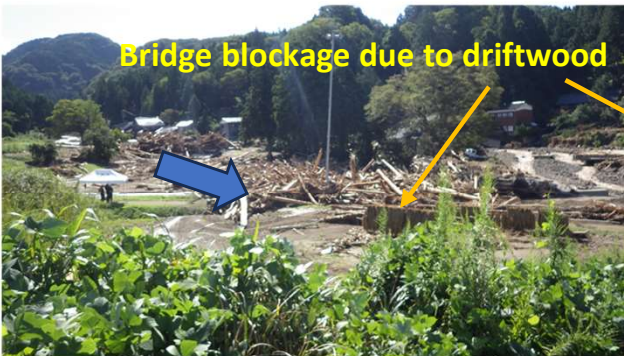
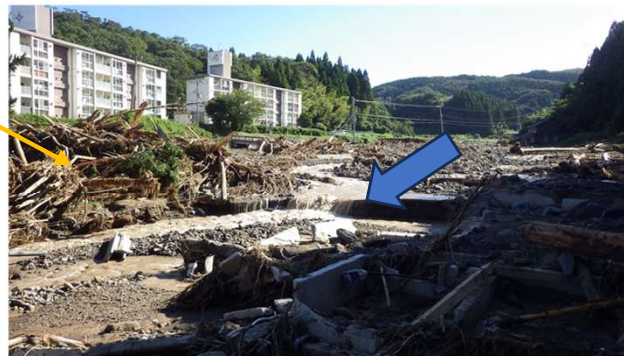
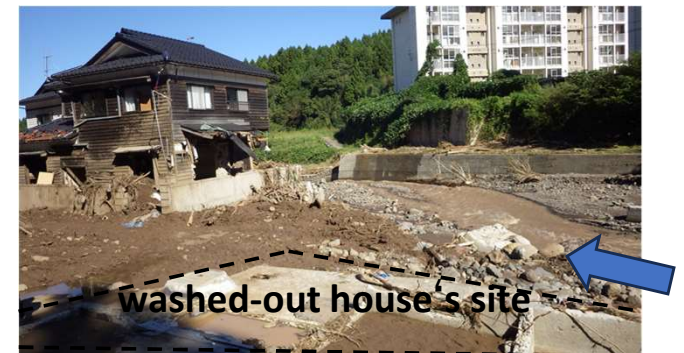
A、B: Sediment and flood damage due to bridge blocked by driftwood

C: Loss of houses due to direct hit by sediment and flood:

- Sediment and driftwood from the upstream collapse site caused by the January 2024 earthquake likely caused significant damage.
- Sediment accumulation in the channel caused the channel bed to rise and the channel cross section to decrease. Floodwaters inundated outside the channel for approximately 90% of the channel length.
- Four bridges were blocked by a large amount of driftwood, which caused sediment entrapment and sediment and flood damage of the stream channel upstream of the bridges.
- Floodwaters flowed out of the channel near bridges blocked by driftwood, and the flow was concentrated near houses, resulting in human and house damage.
