Slope Stabilization Works by Green Lexar Method for the 2nd Sabo Dam at Shiritaka Valley,

Tochio Branch Office, Jintu River Sabo Project Office

1. Outline of the Construction Work

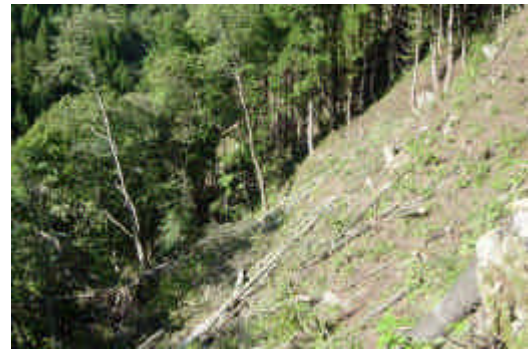
Situation of slope after felling hindrance trees

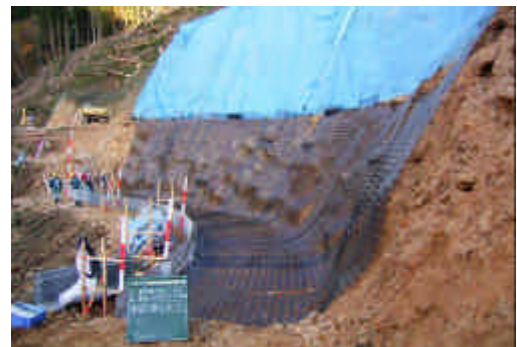
Situation of the footing net

The material for the surface shield and tie is galvanized iron expanded net, of which zinc content is 500g/m, footing net of which the commodity name is geonet and is made of plastic.
